PAVEMENT RECONSTRUCTION CHALLENGES AND INNOVATIONS ON I-40 WEST OF FLAGSTAFF

ADOT Geotechnical Services Section

November 15, 2018

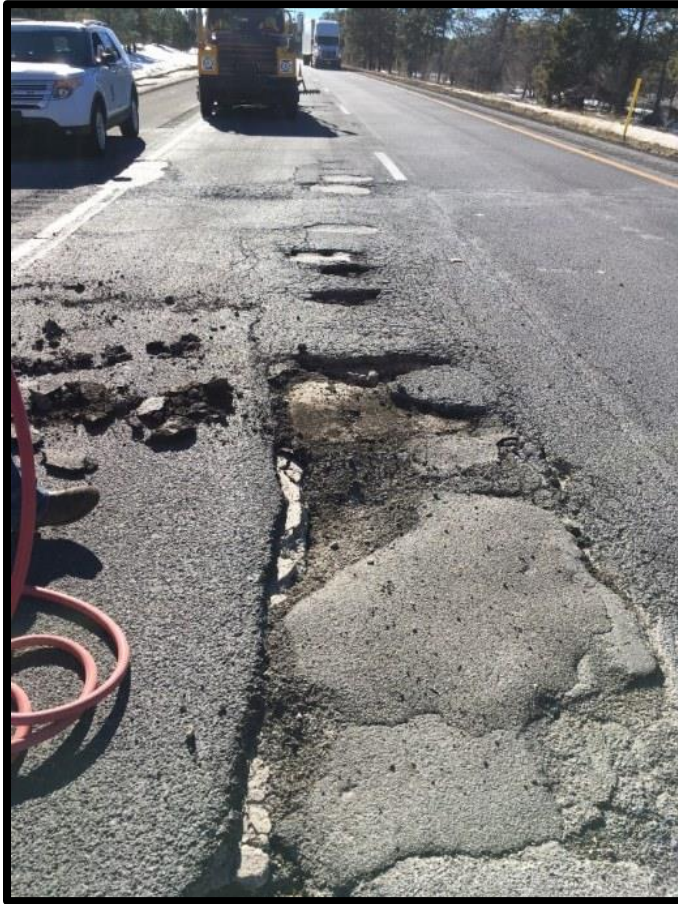
Spalling PCCP beneath AC Overlay

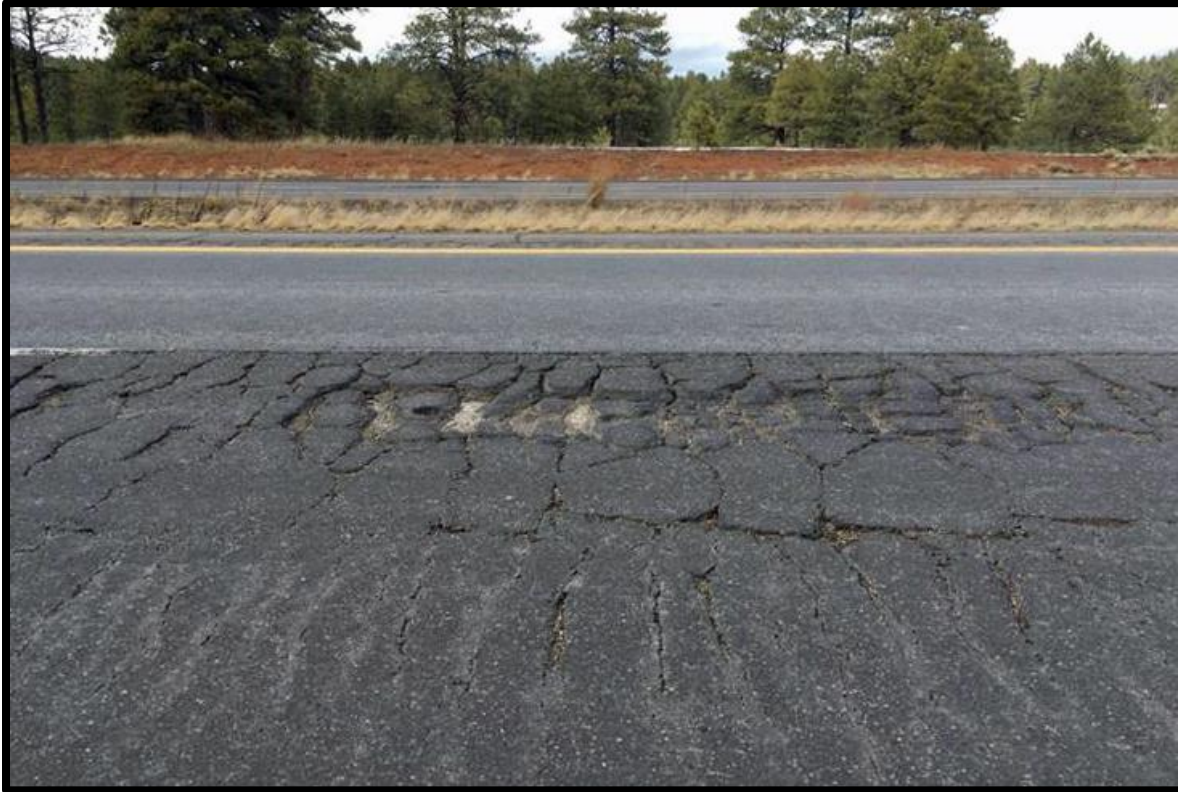
Pavement Failures

- ▶ Section of I-40 was constructed in about 1967
- ▶ Scoped as a pavement rehabilitation project
- ▶ 17 miles of milling and replacing surface asphalt
- ▶ East of Williams and extended to Parks, Arizona
- ▶ Several areas of pavement showed signs of full depth failure during the winter of 2016/2017

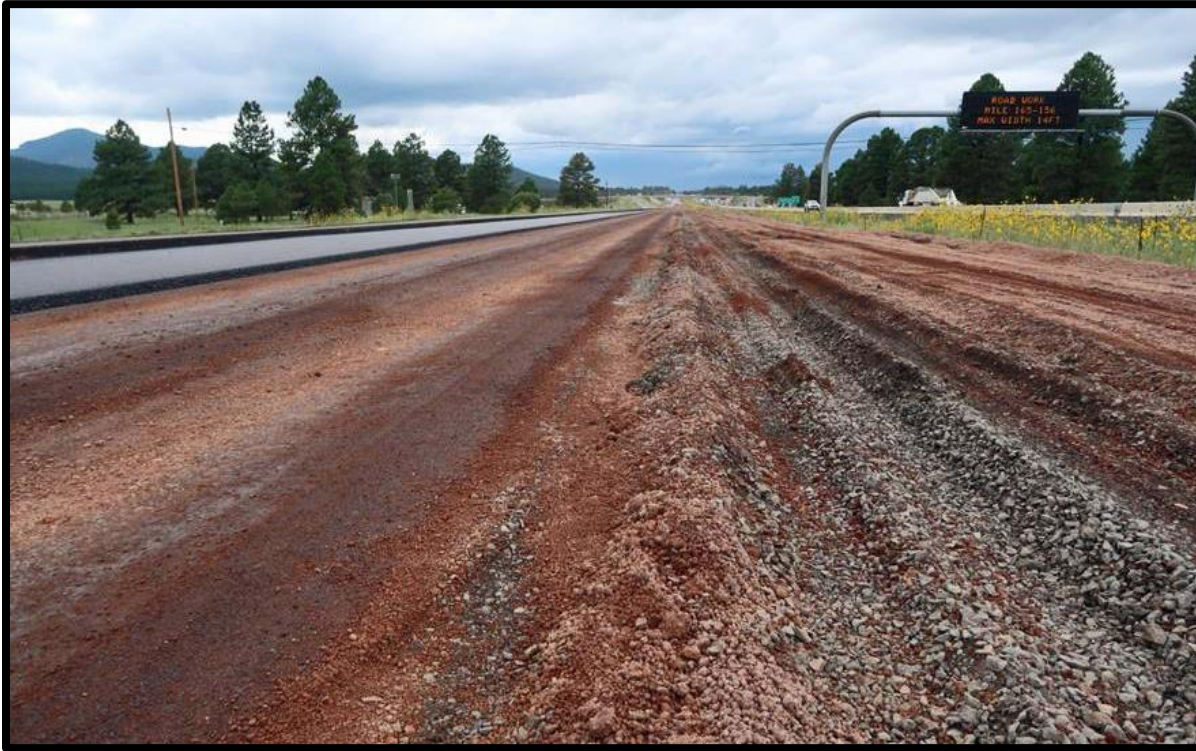
Notice rutting of
untreated
cinders on right
side

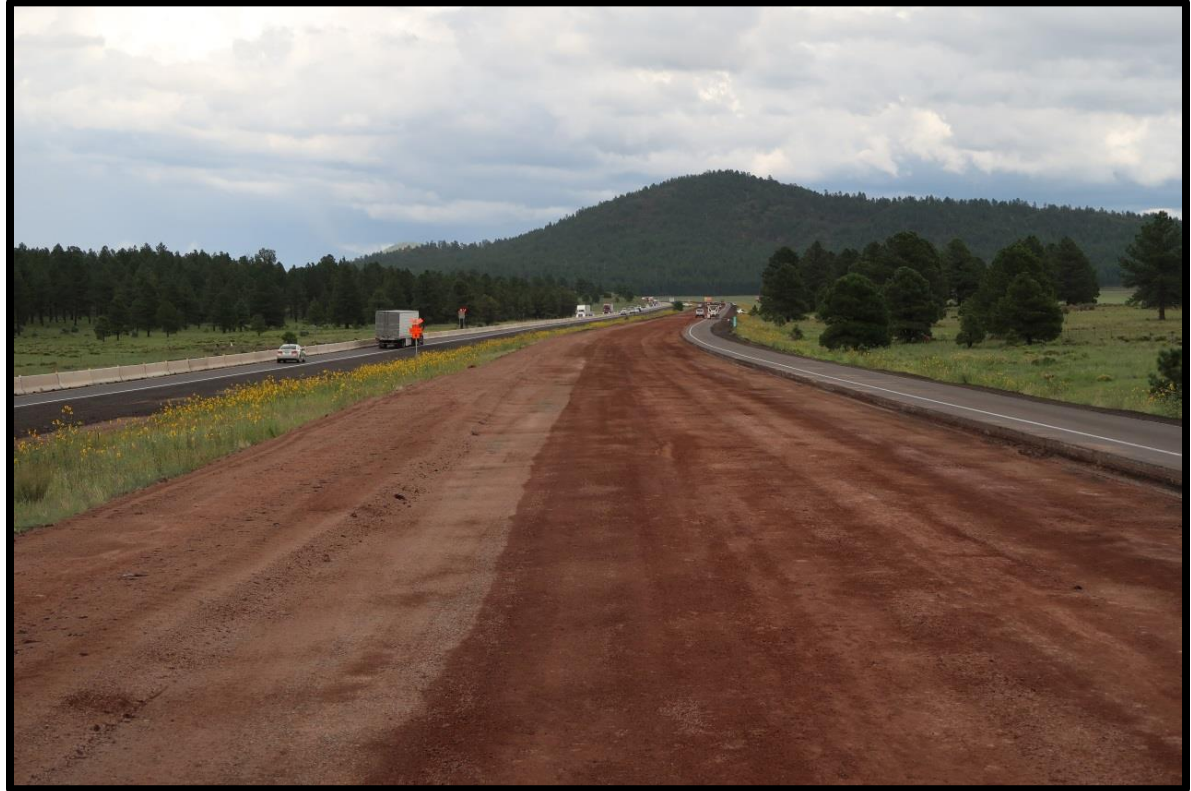
Finished
cement
treated cinders
in the middle
of image
