Innovations in Full Depth Reconstruction of Interstate Roadways in Arizona

Tad Niemyjski, P.E.
ADOT Geotechnical Services Section

Arizona Pavement/Materials Conference
November 16, 2023

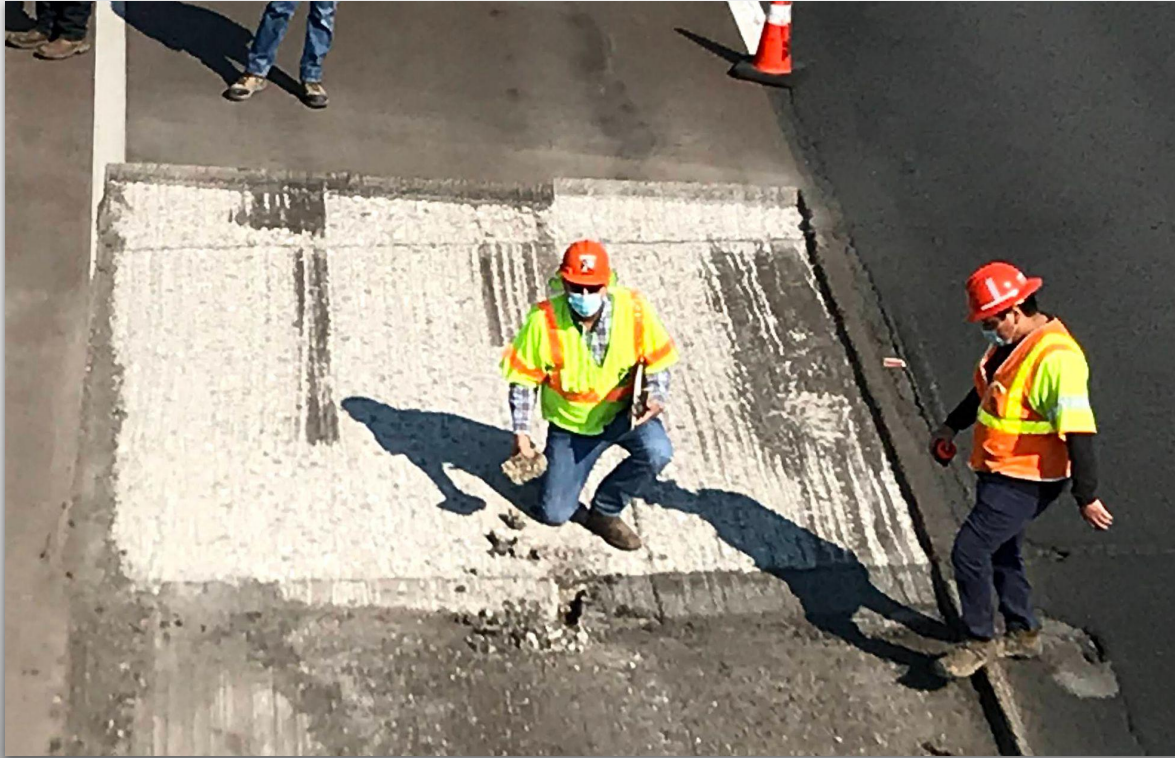
I-17 Pavement in 2020

Became much
worse during last
winter

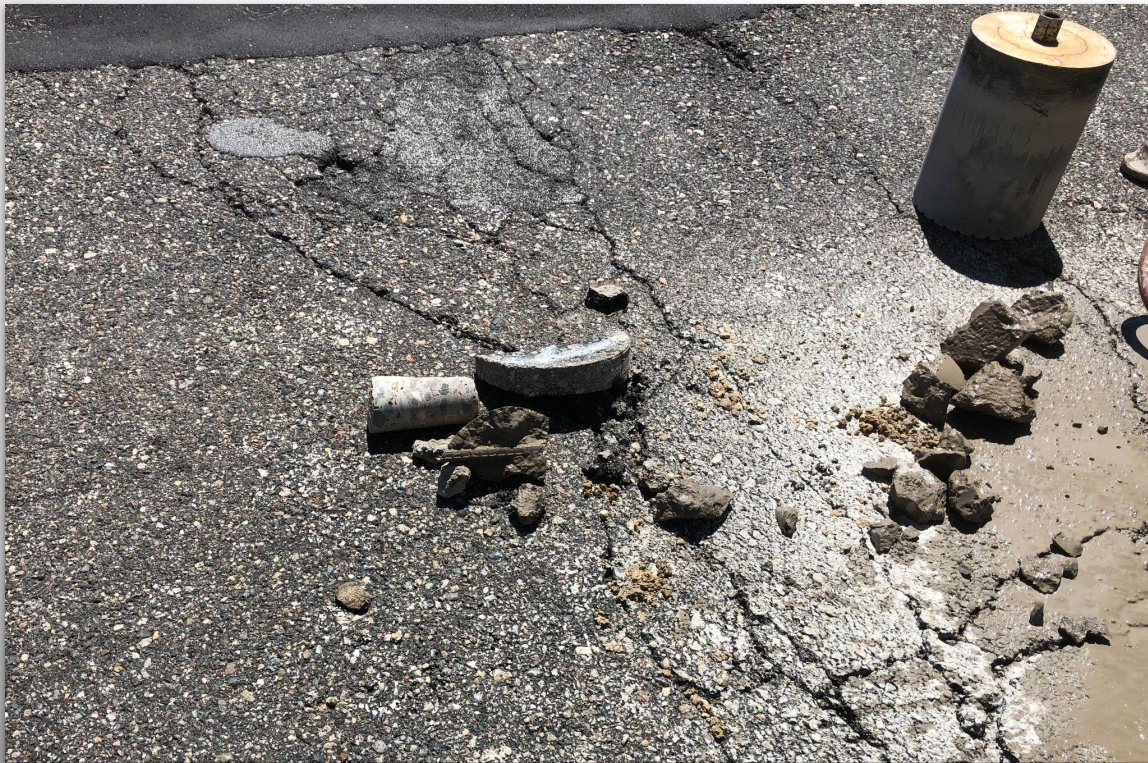
Taking a peak at
the PCCP slabs
in 2020

Pieces of
concrete pulled
out with a rock
pick

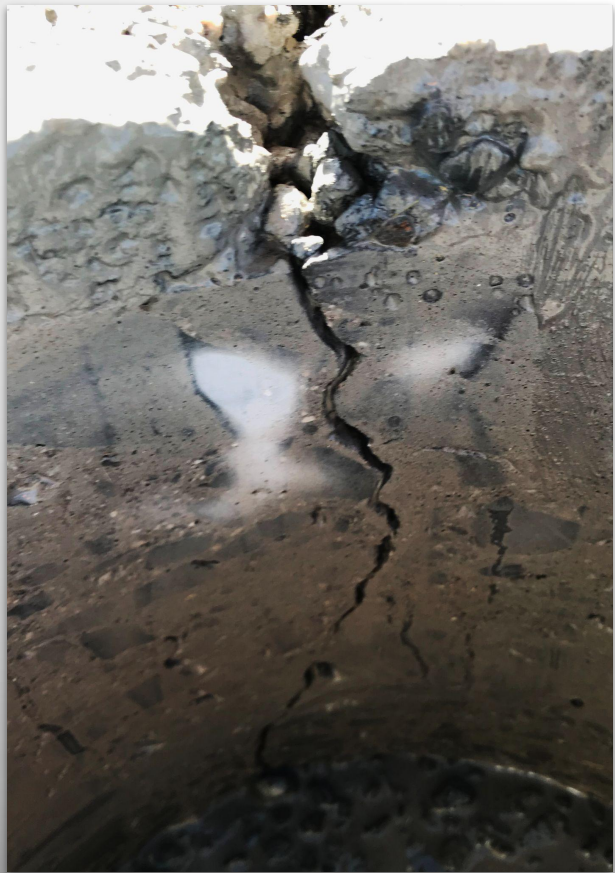
Pavement Core in
failed pavement
area

Full depth cracking of PCCP slabs was observed in many locations.

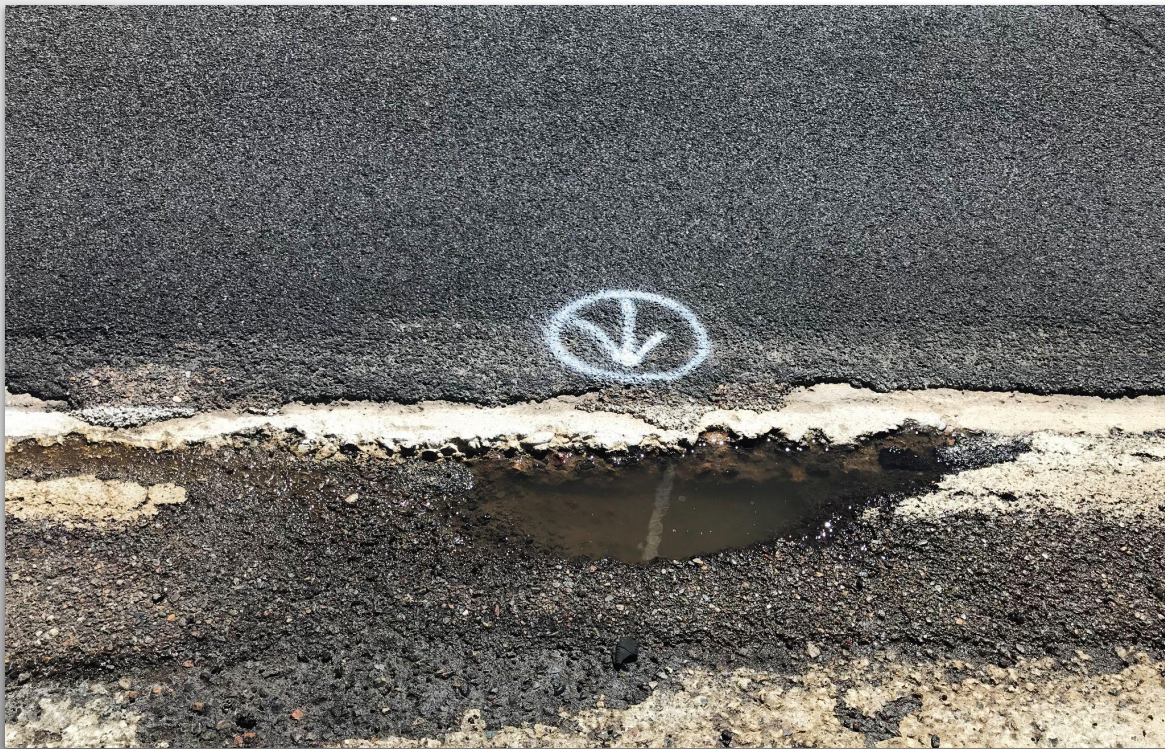
Excessive water content within the base course materials was suspected to be an issue contributing the the roadway failures.

Many areas of
I-17 displayed
water
accumulation

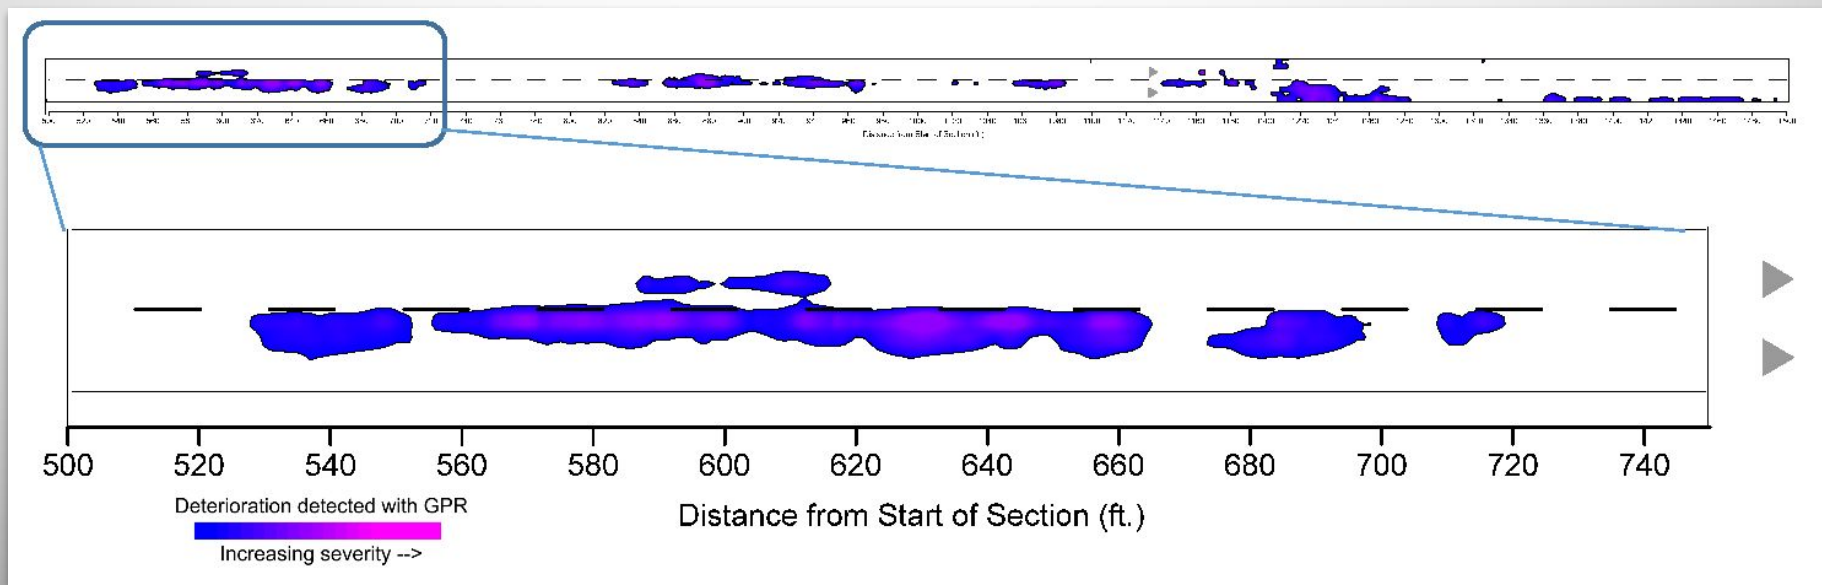
Concrete deterioration mapping

Pavement deterioration mapping of both lanes was developed based on GPR data.

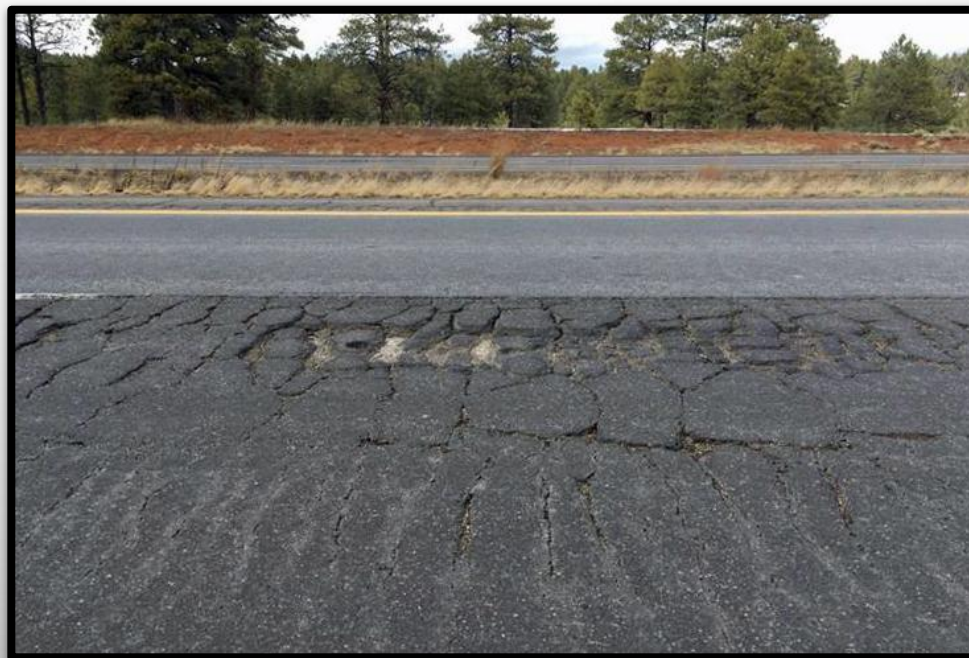
Full depth failures east of Williams, 2017

- Several areas of pavement showed signs of full depth failure during the winter of 2016/2017
- Project used cement to stabilize the existing cinter base materials
- Project was completed in 2018

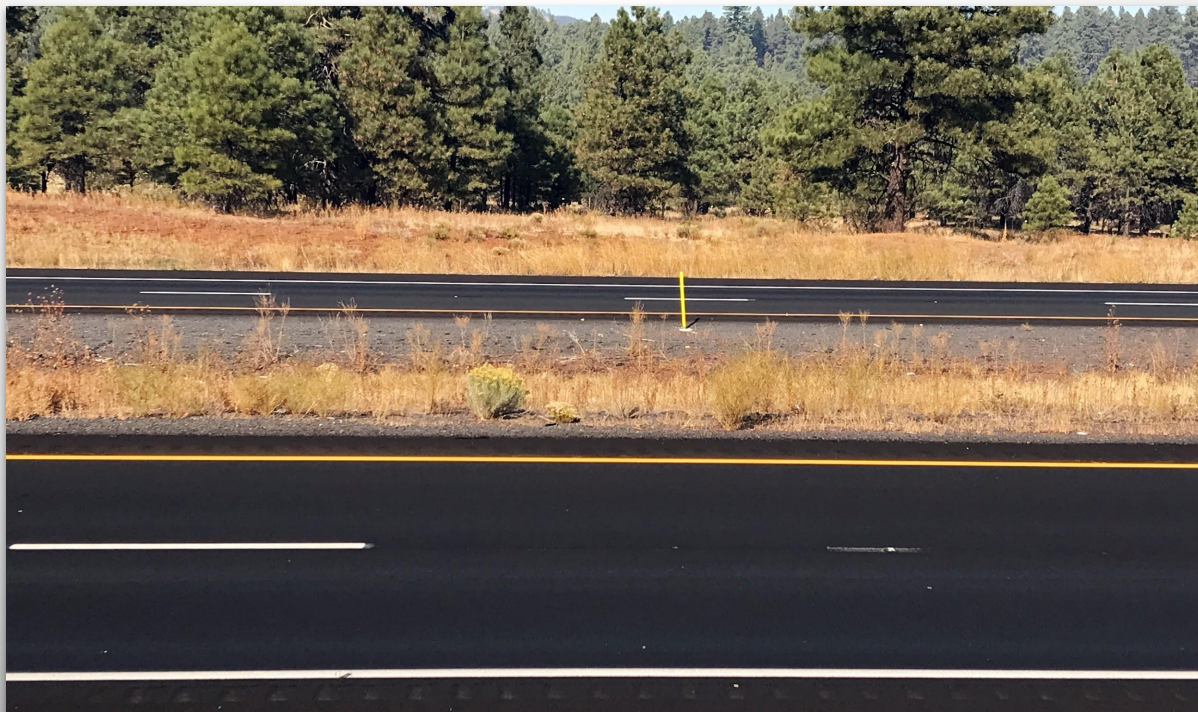
I-40 today, east of Williams today

- Five winters have passed since construction began.
- The pavement within the limits of this project currently shows no signs of distress.
