# 3D Laser Imaging for Pavement Survey at 60 mph and True 1mm Resolution

#### Kelvin C. P. Wang

#### **Oklahoma State University & WayLink**

2013 Arizona Pavements/Materials Conference ASU MU, November 13-14, 2013

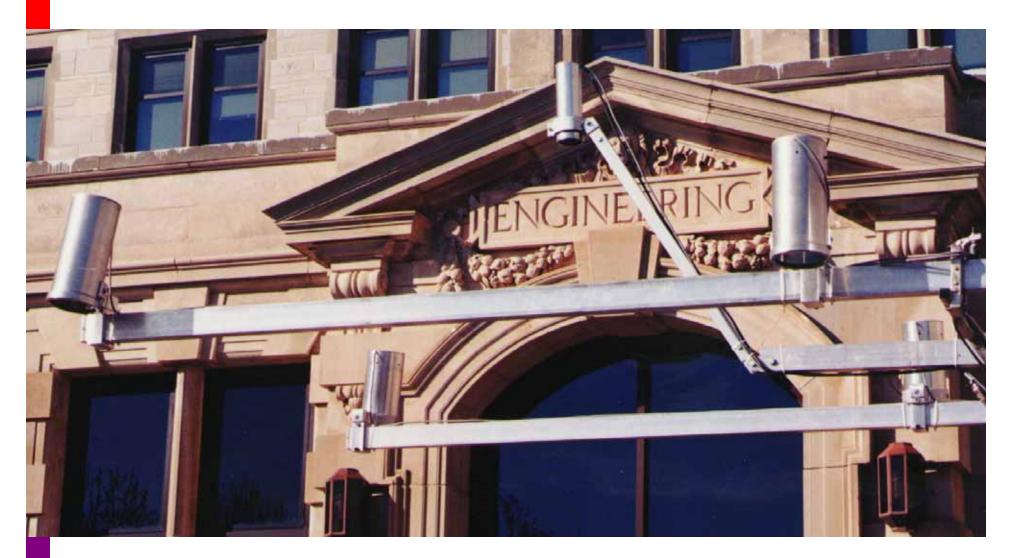
#### First Gen Vehicle's Exterior

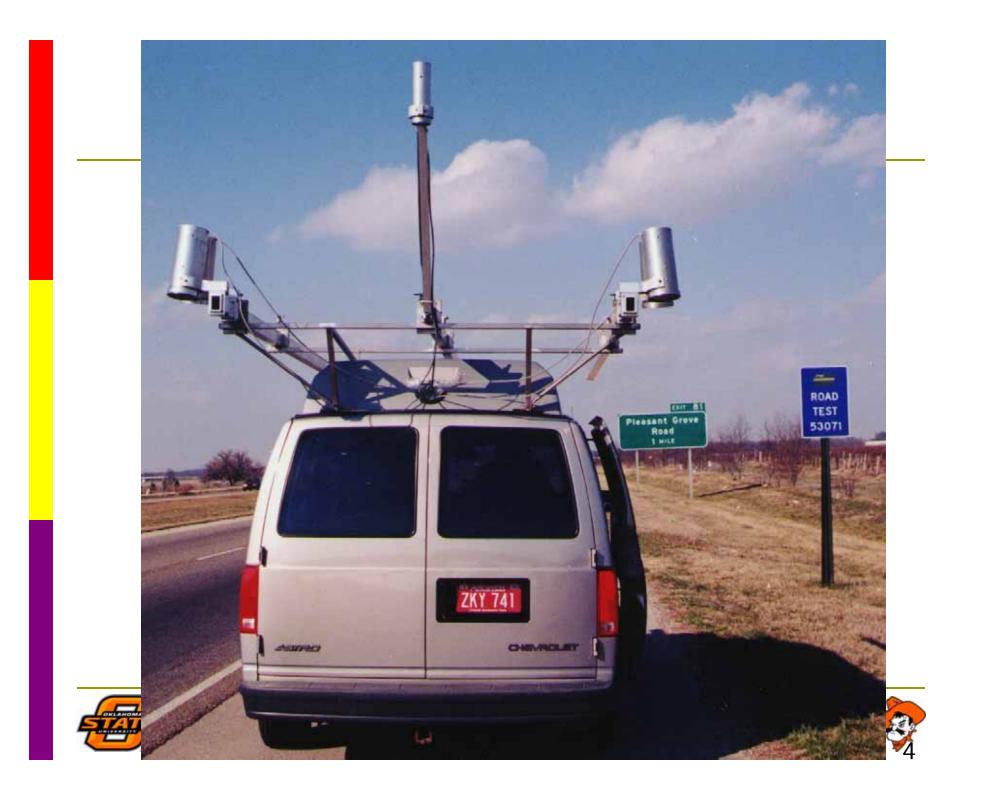
#### Telescoped Camera and Four Strobe Lights

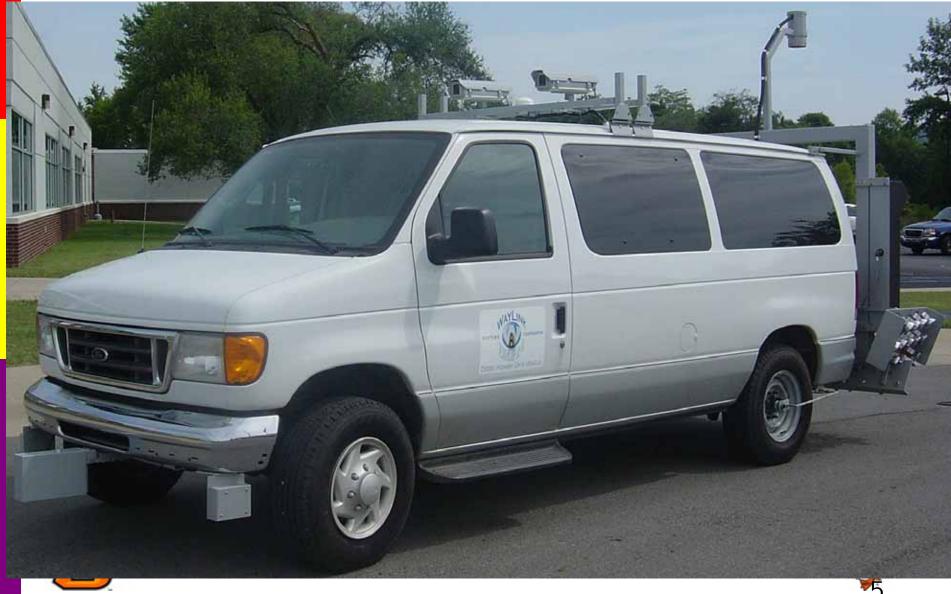
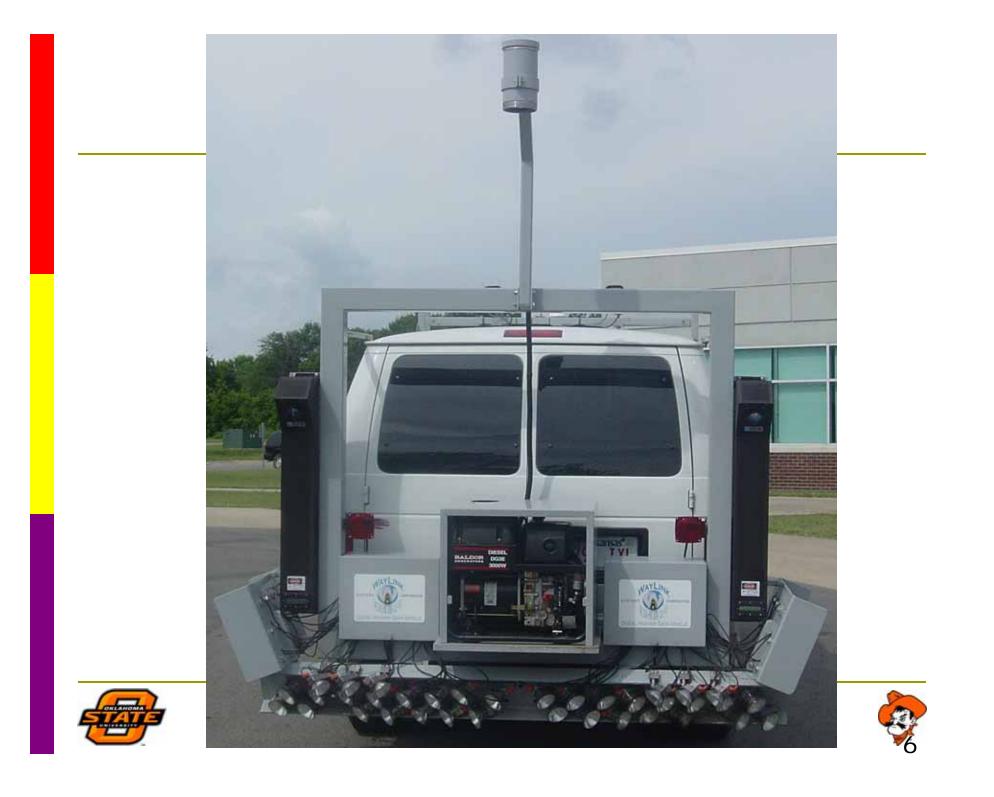
#### **Second Generation DHDV**

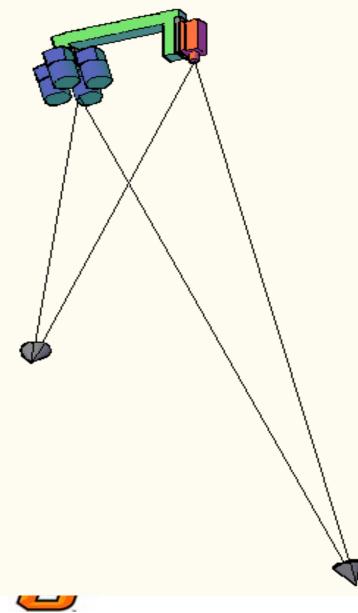
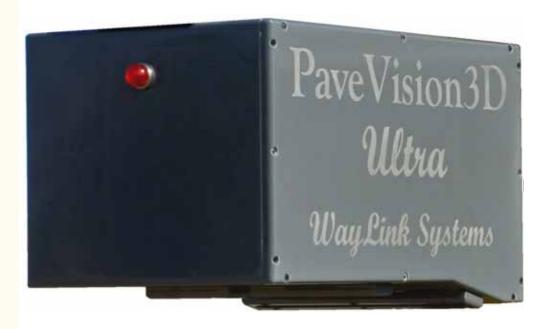
## **PaveVision3D Ultra Design**

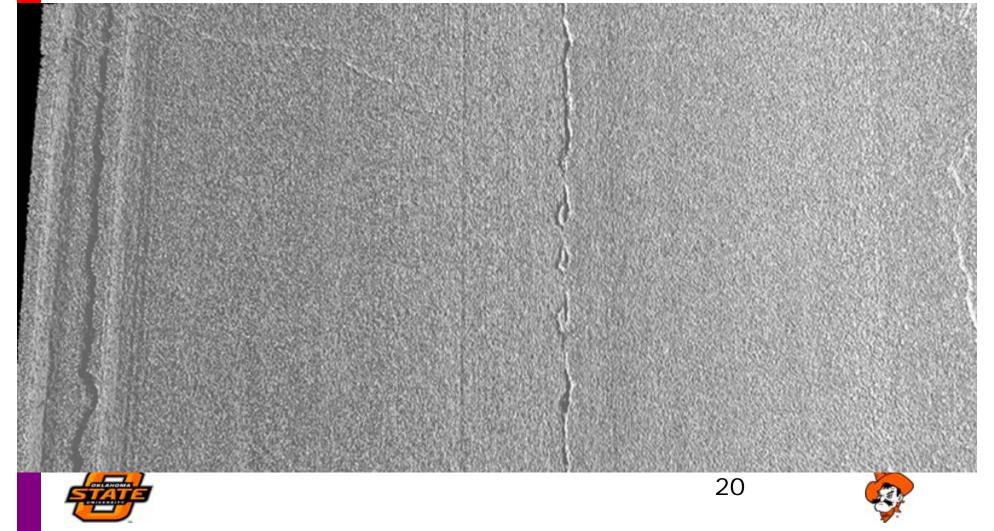
# **Comparison on the Same Pavement D**7000 3D Profiles/Sec

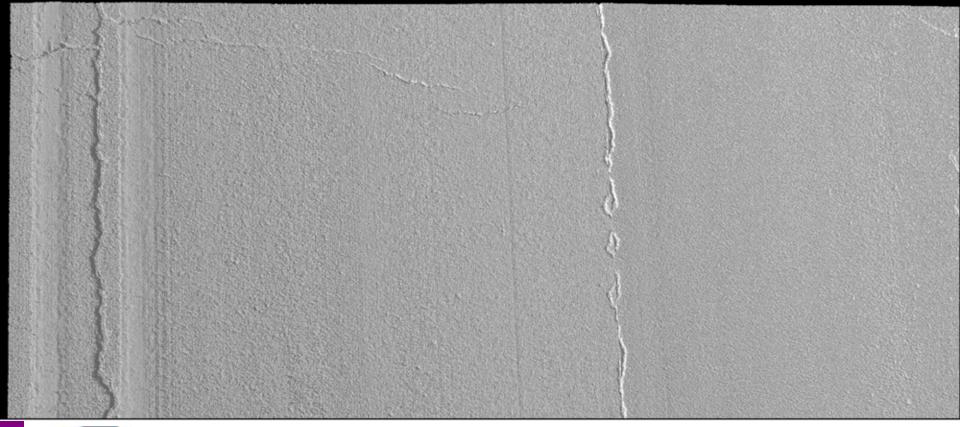
# **Comparison on the Same Pavement** 28,000 3D Profiles/Sec

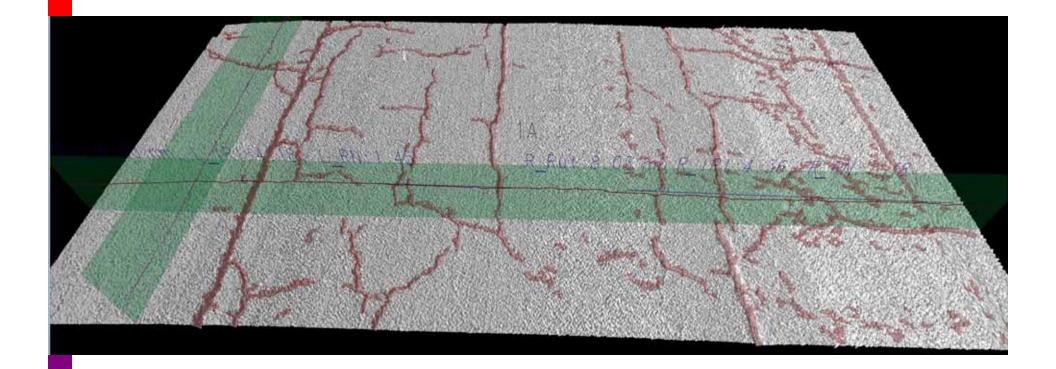
# **Cracking & Profiling**

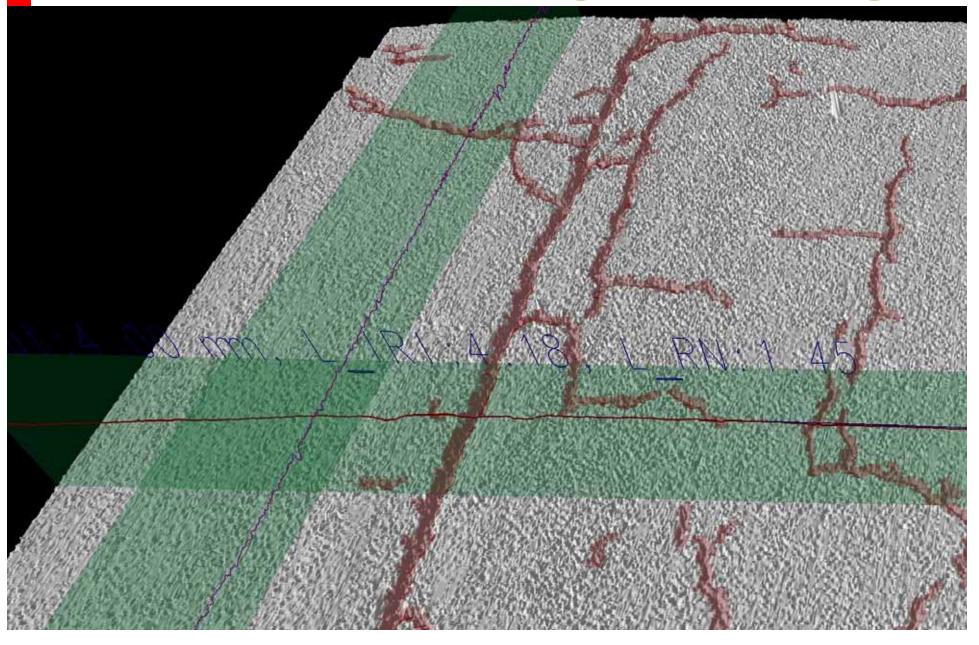
### Zoomed-In, Cracking & Profiling

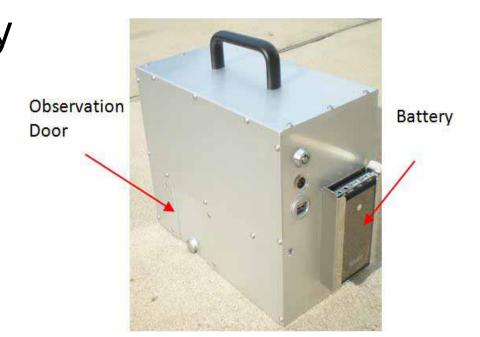
### **LS-40 Pavement Surface Analyzer**

Scanned Area:

- 4.5" long by 4" wide
- Data Pixel Quantity
  2048 x2448
  Horizontal Resolution
   0.056mm

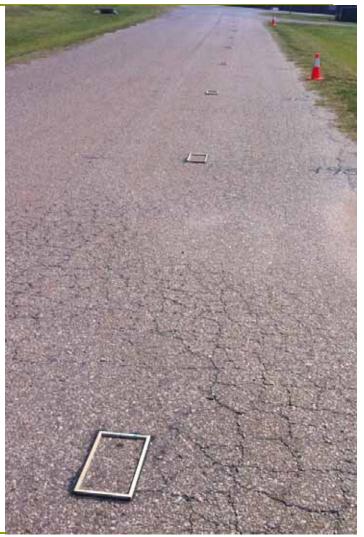
## **Experimental Setup**

- 21 areas marked on pavement
  - Evenly spaced (15ft)
  - Ift long by 6 in wide
- Texture Measurements
  - Within marked area
  - LS40 MPD: static 5 runs
  - PaveVision3D MPD: two speeds, 10 runs each

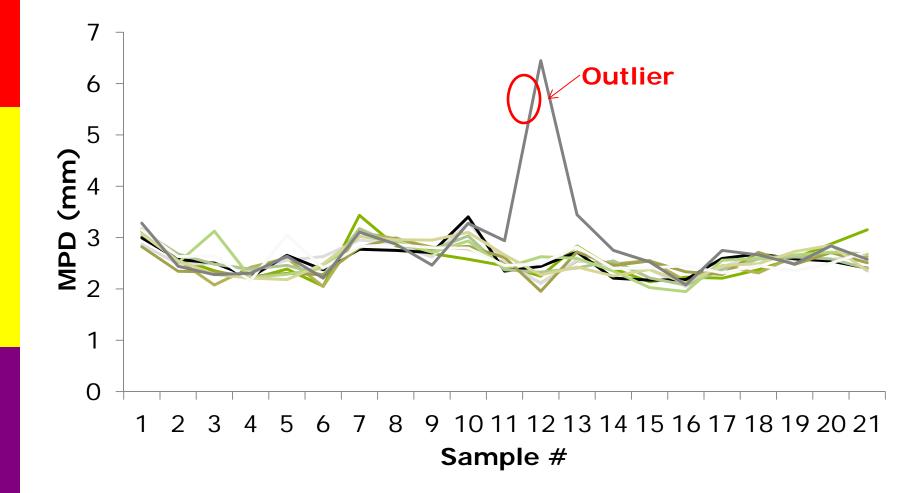
### PaveVision3D MPD (7mph)

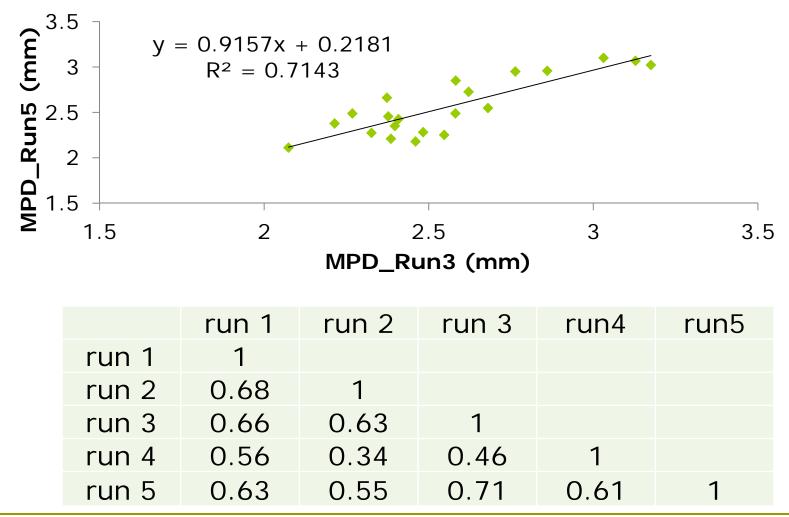
### **Correlation Analysis(7mph)**

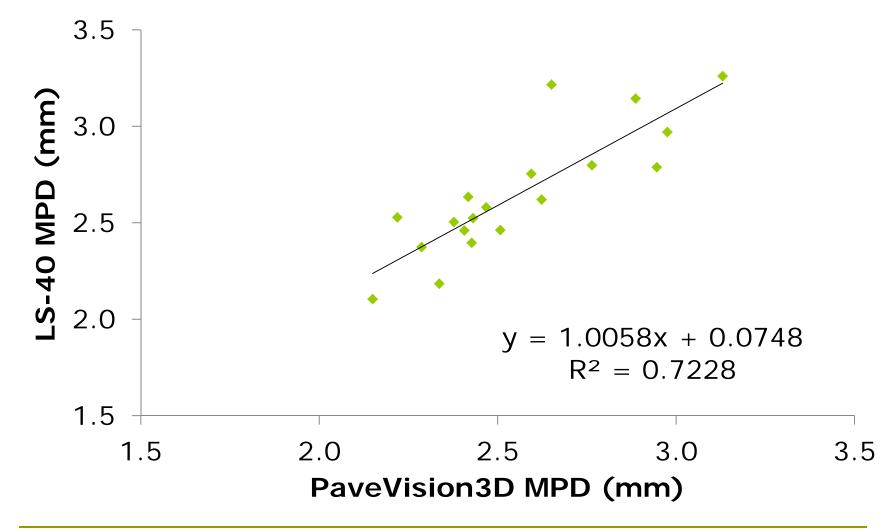
## **Comparison Analysis (7mph)**

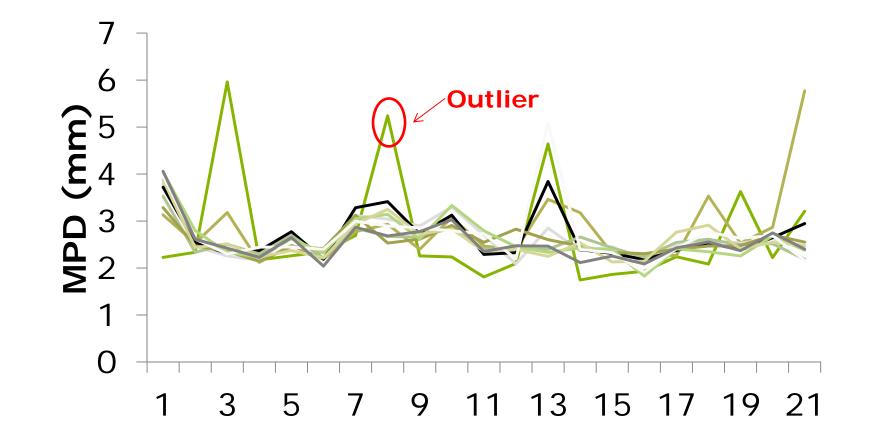
### **PaveVision3D MPD (15mph)**

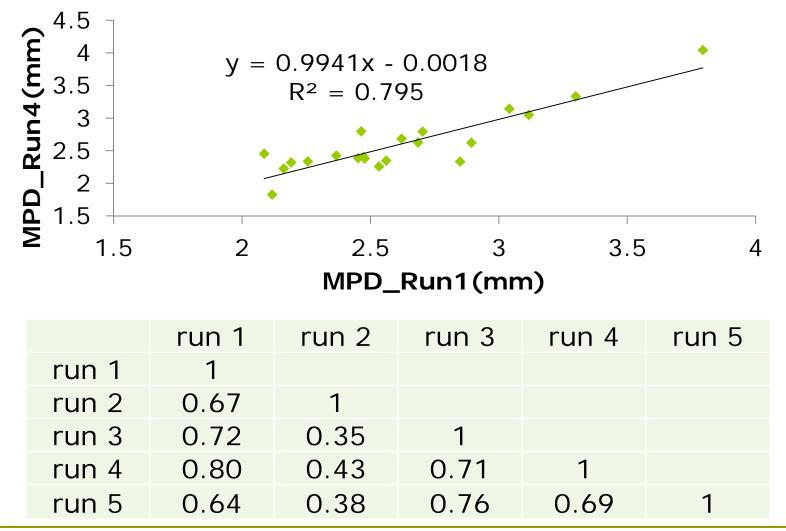
## **Correlation Analysis (15mph)**

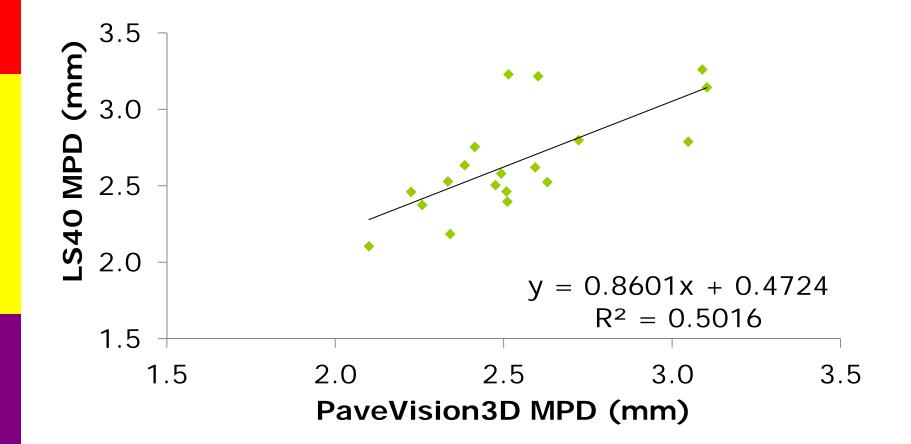
### **Comparison Analysis (15mph)**

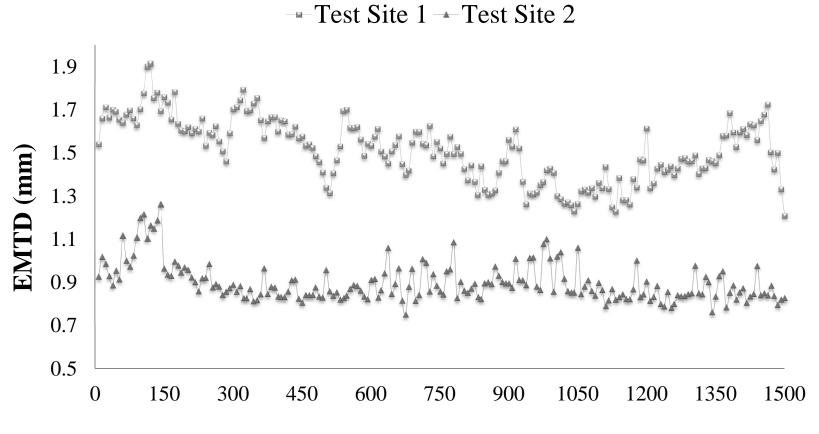
### **Drainage Evaluation Test Results**

Section Length (ft)

- Consisting of accelerometers and fiberoptic gyroscopes
- Collecting positioning, cross slope and vertical slope data
- PaveVision3D Texture Data
- Hydroplanning Speed Model
  - Water film depth: pavement type, cross slope, vertical grade, rain intensity

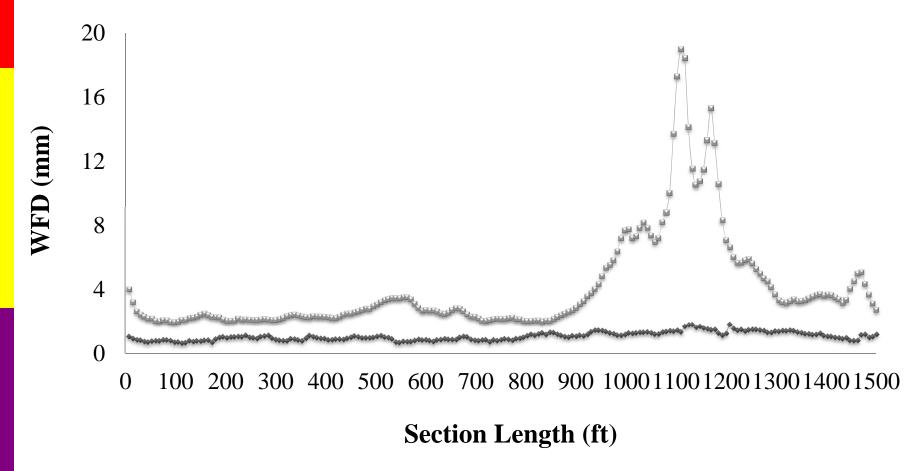
#### **Drainage Evaluation Test Results**

→ Test Site 1 → Test Site 2

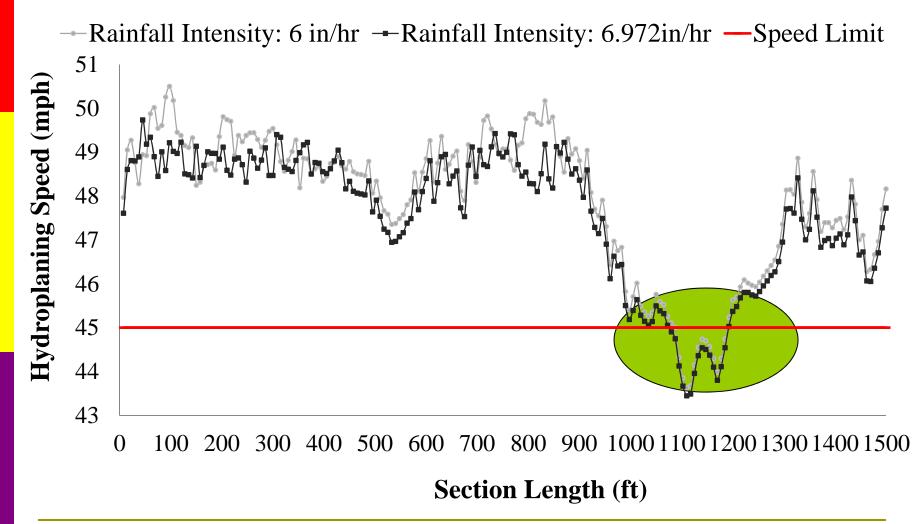
### **Drainage Evaluation Test Results**

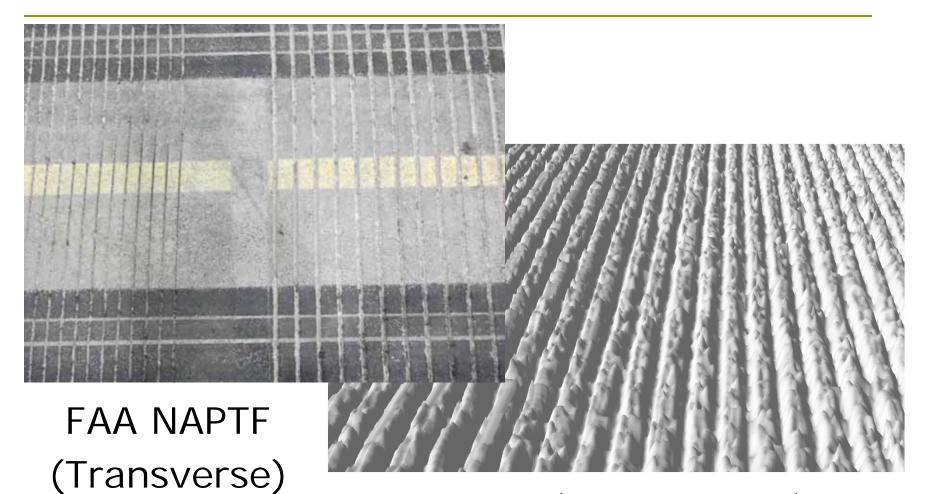
### Grooving

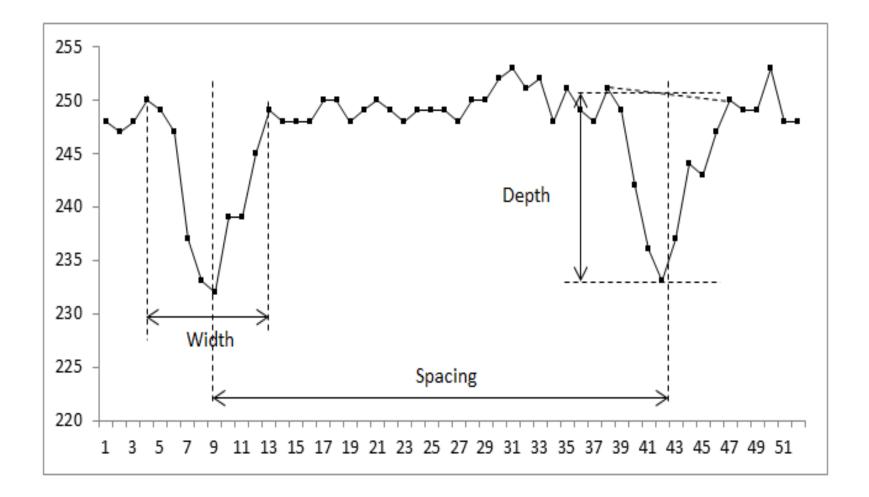
#### **Groove Dimensions**

- To develop an algorithm to automatically estimate groove dimensions
  - Groove Depth
  - Groove Width, and
  - Groove Spacing
- To evaluate groove performance
  - Calculated groove dimensions
  - Groove configuration, and
  - Standard groove evaluation guidelines

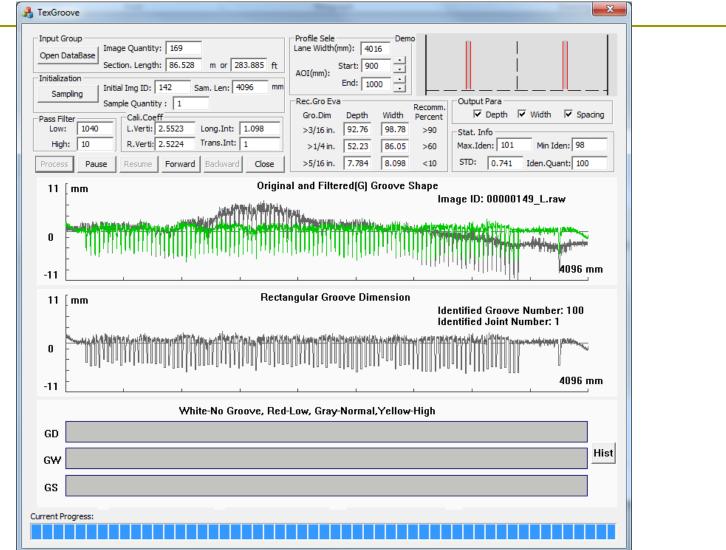
#### **Software Interface**

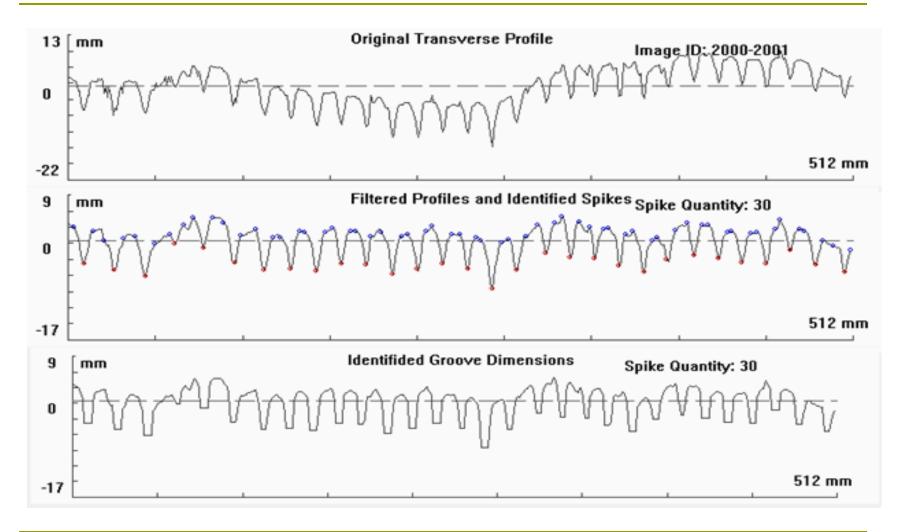
#### **Identification Results**
