Follow the Yellow Striped Road But Watch Out for that Manhole

By:
Hunter Venne

PAVEMENTS/MATERIALS CONFERENCE

Dibble
Engineering

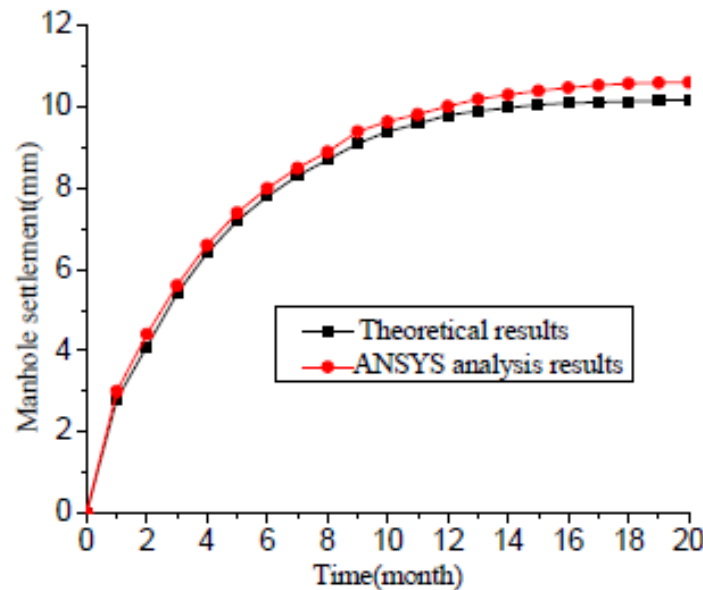
- ❑ ASCE Study: Effects of traffic on manhole settlement (Longitudinal Vibration) (4)
 - The model was not perfect, and they recommend further studies
