# Evolution of Pavement Design at ADOT

Arizona Department of Transportation

2012 Arizona Pavements / Materials Conference

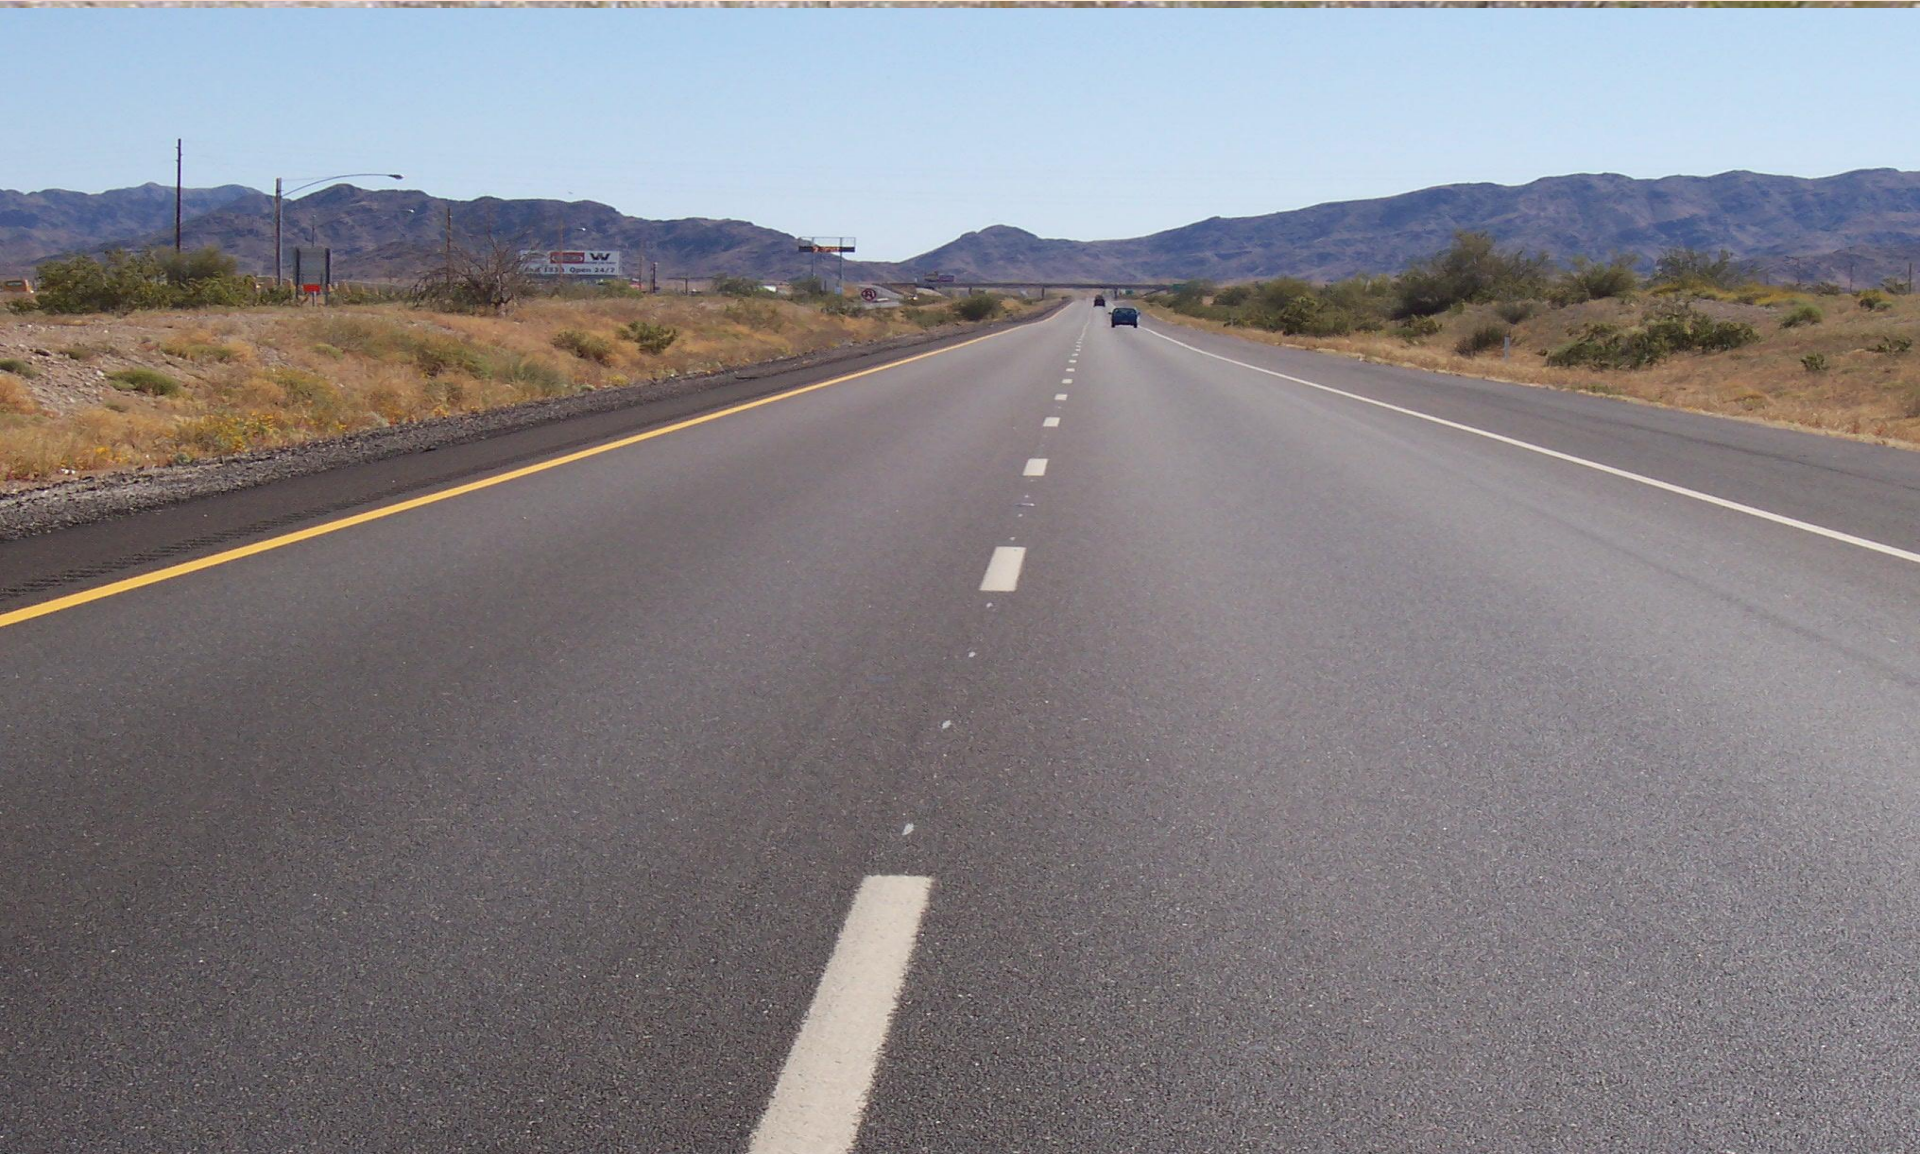
# Example AZ Composite Design:

- Constructed 1994, outer lane
- 0.5-in ARFC
- 14-in JPCP, 1.5-dowels, widened slab
- 13, 15, 17-ft perpendicular joint spacing
- 6-in Aggregate base
- HMA shoulders

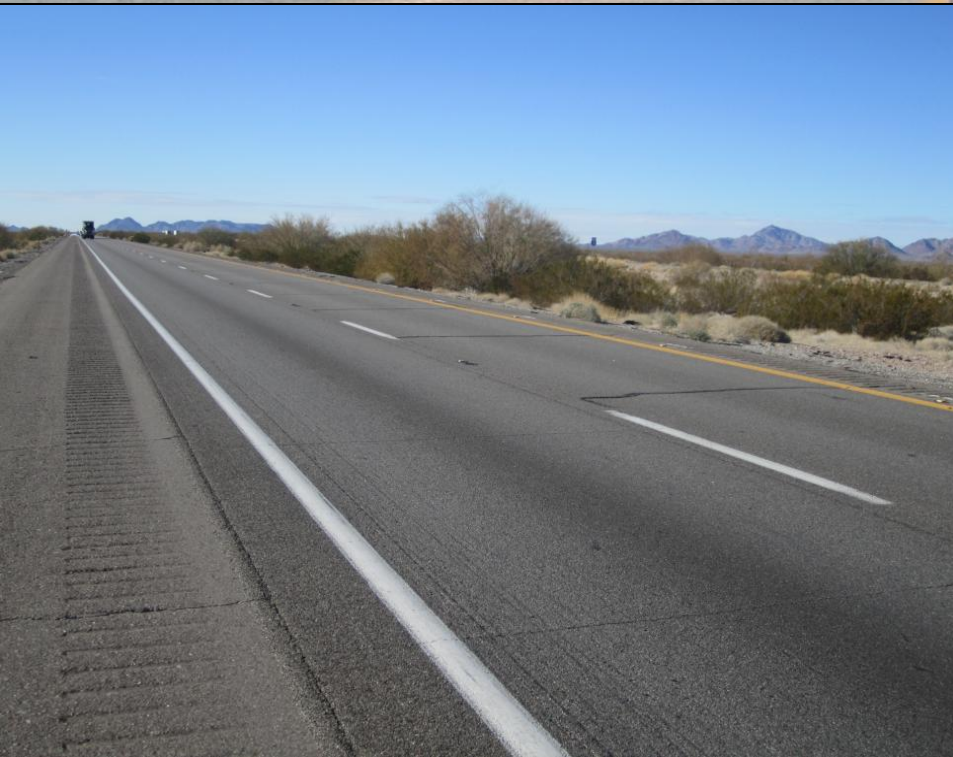
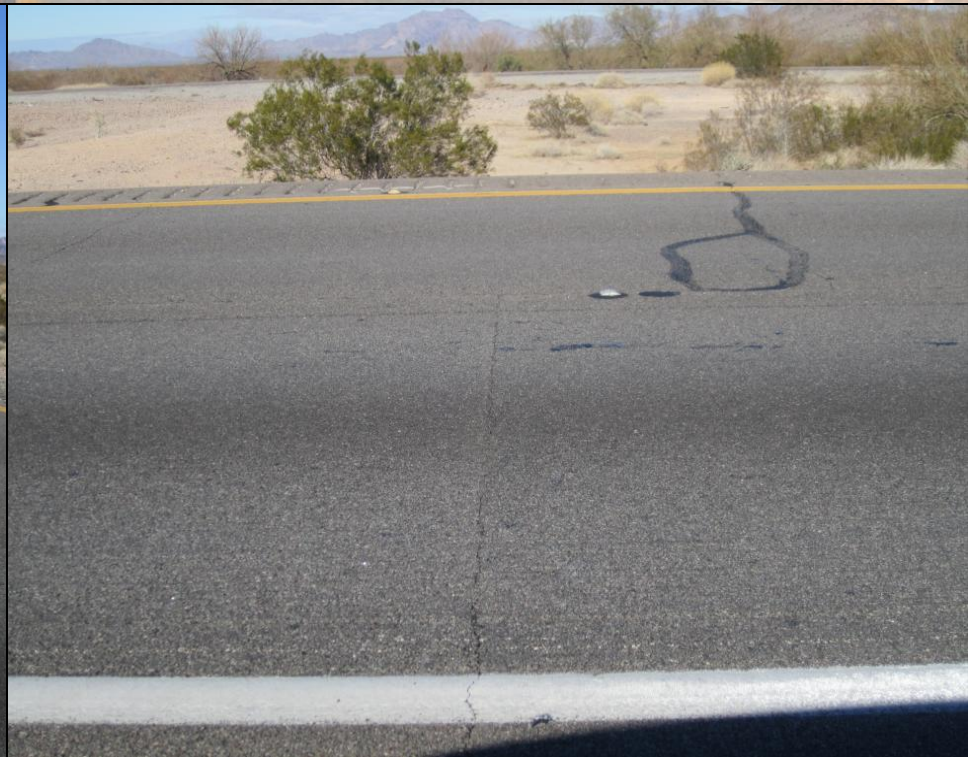
# Existing Composite ARFC/JPCP (Calibration Site)

After 17 years  
IRI = 54 in/mi

Negligible rutting,  
trans. jt. refl. cracks  
no JPCP fatigue cracks
