Arizona Pavements/Materials Conference
Tempe, Arizona
November 15, 2018

Geotechnical Challenges Related to the TBM for the Alaska Way Viaduct Replacement Project

Barry D. Siel, P.E.
Senior Geotechnical Engineer
Federal Highway Administration

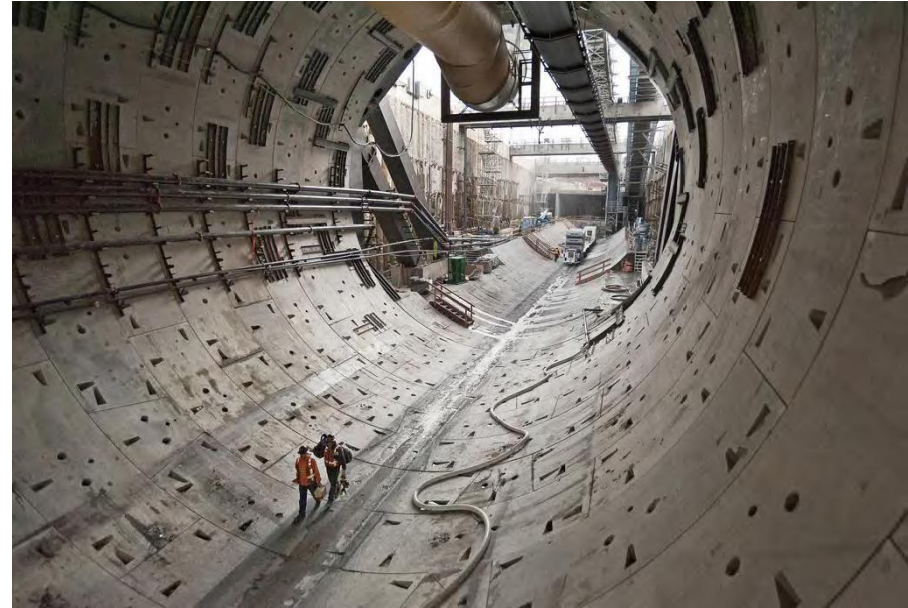
The Tunnel

- **Length: 9,270 feet (1.7 miles)**
- **Diameter: 56 feet (inside finished)**
- **Volume: 850,000 yd³**
- **Concrete Liner Rings: 1426**

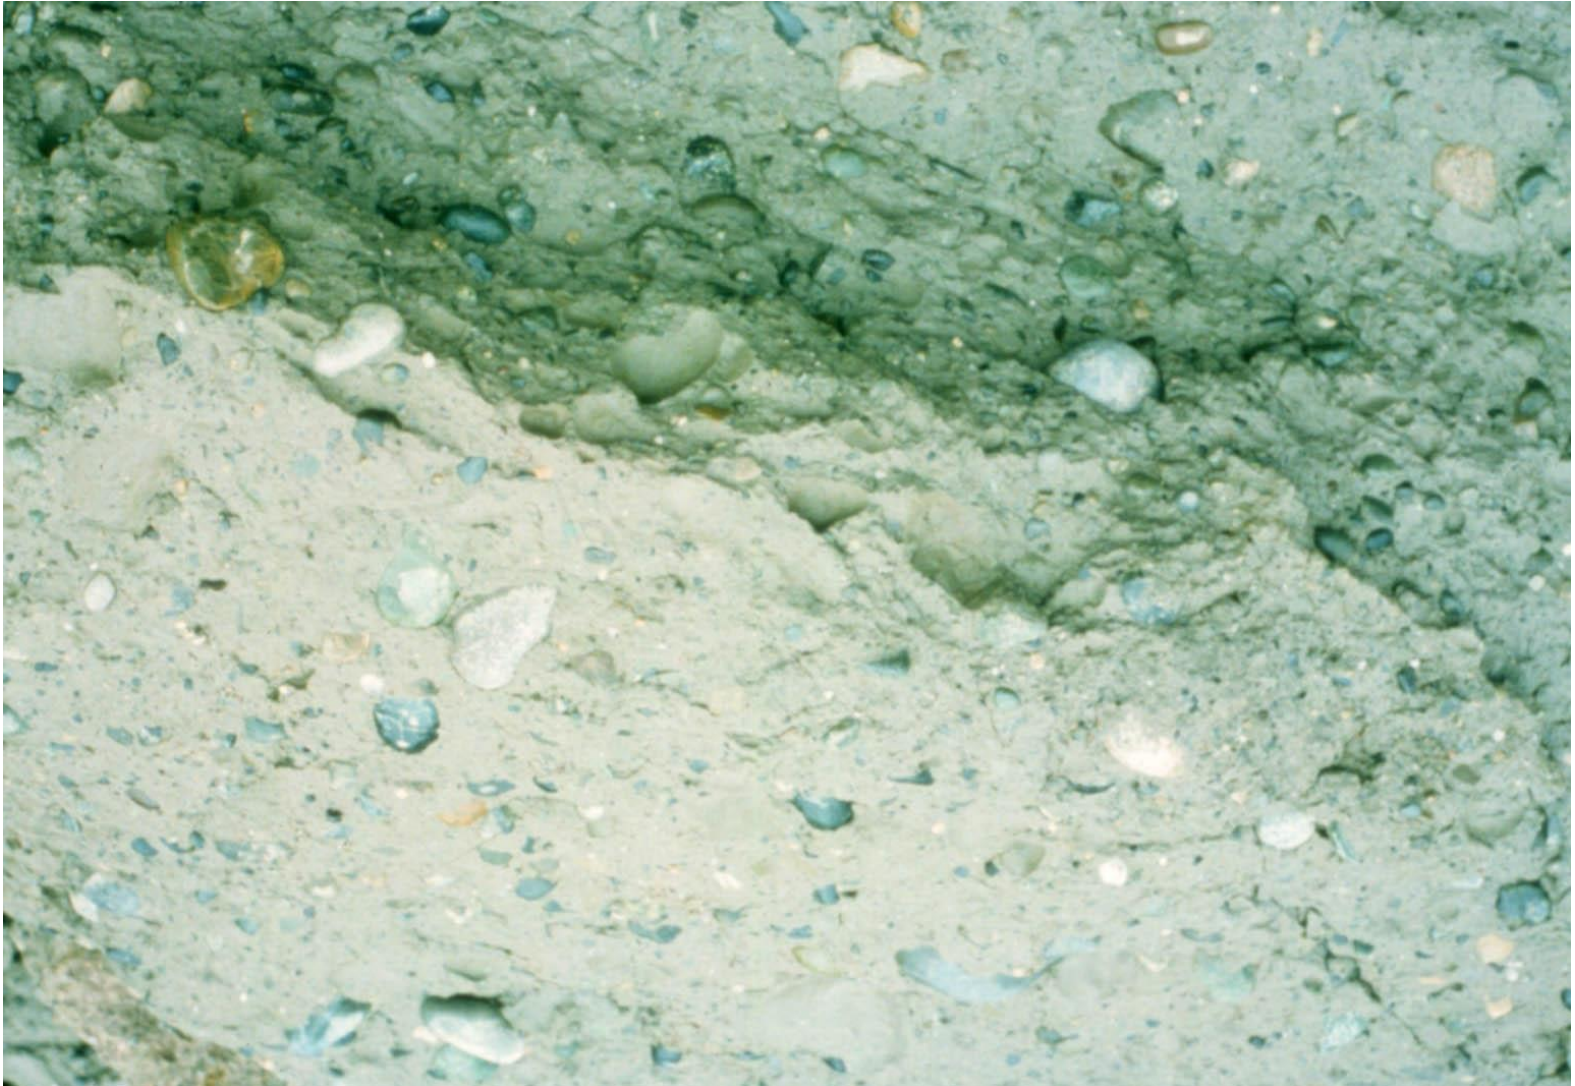
Vashon Glacial Till

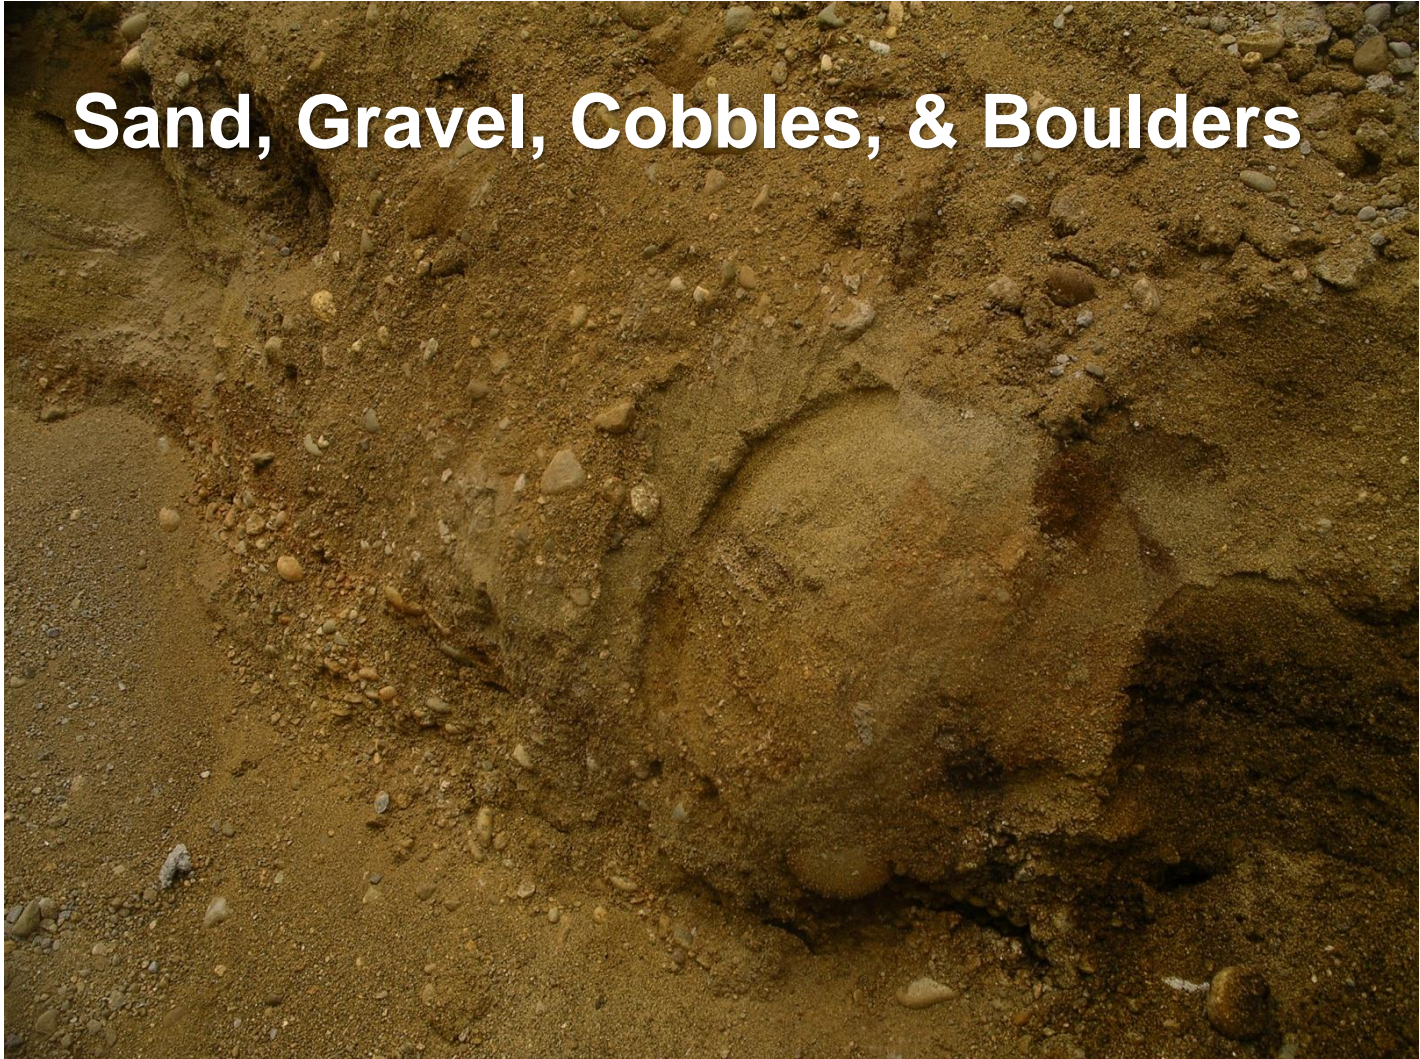
Glacial Outwash

Sand, Gravel, Cobbles, & Boulders

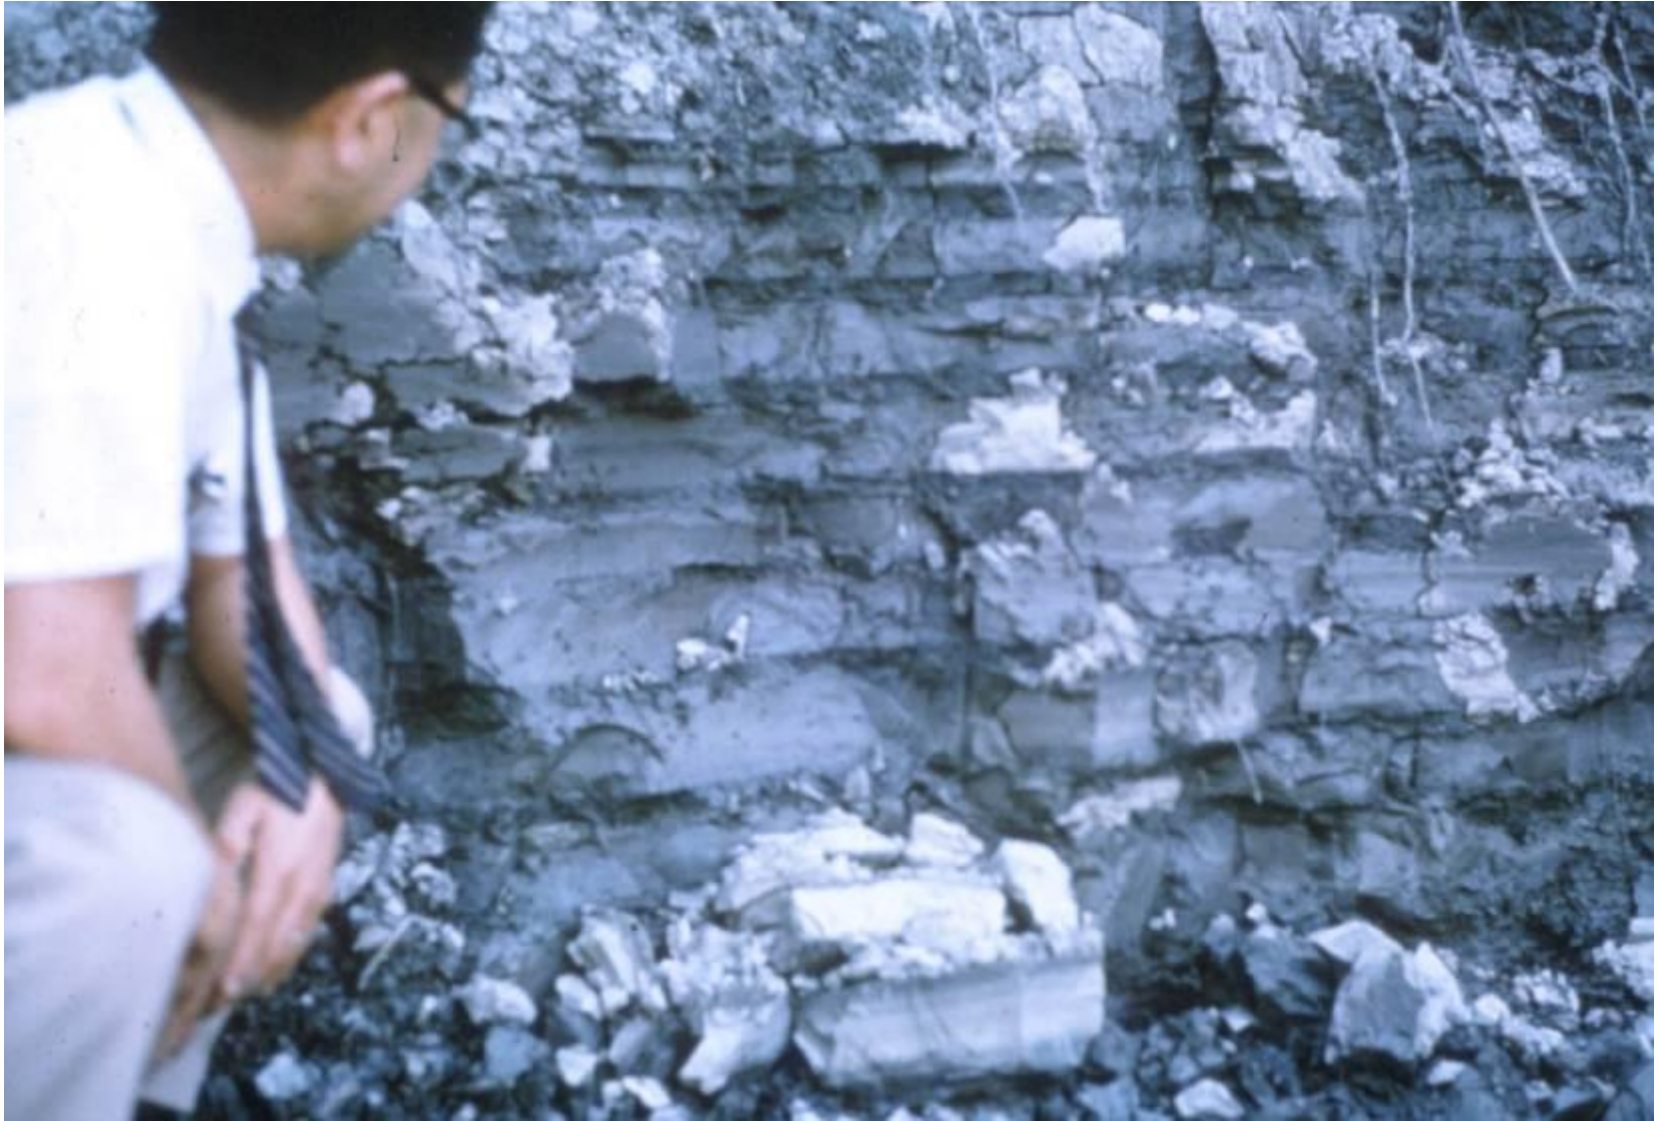
Hard Laminated Glacio-lacustrine Clays

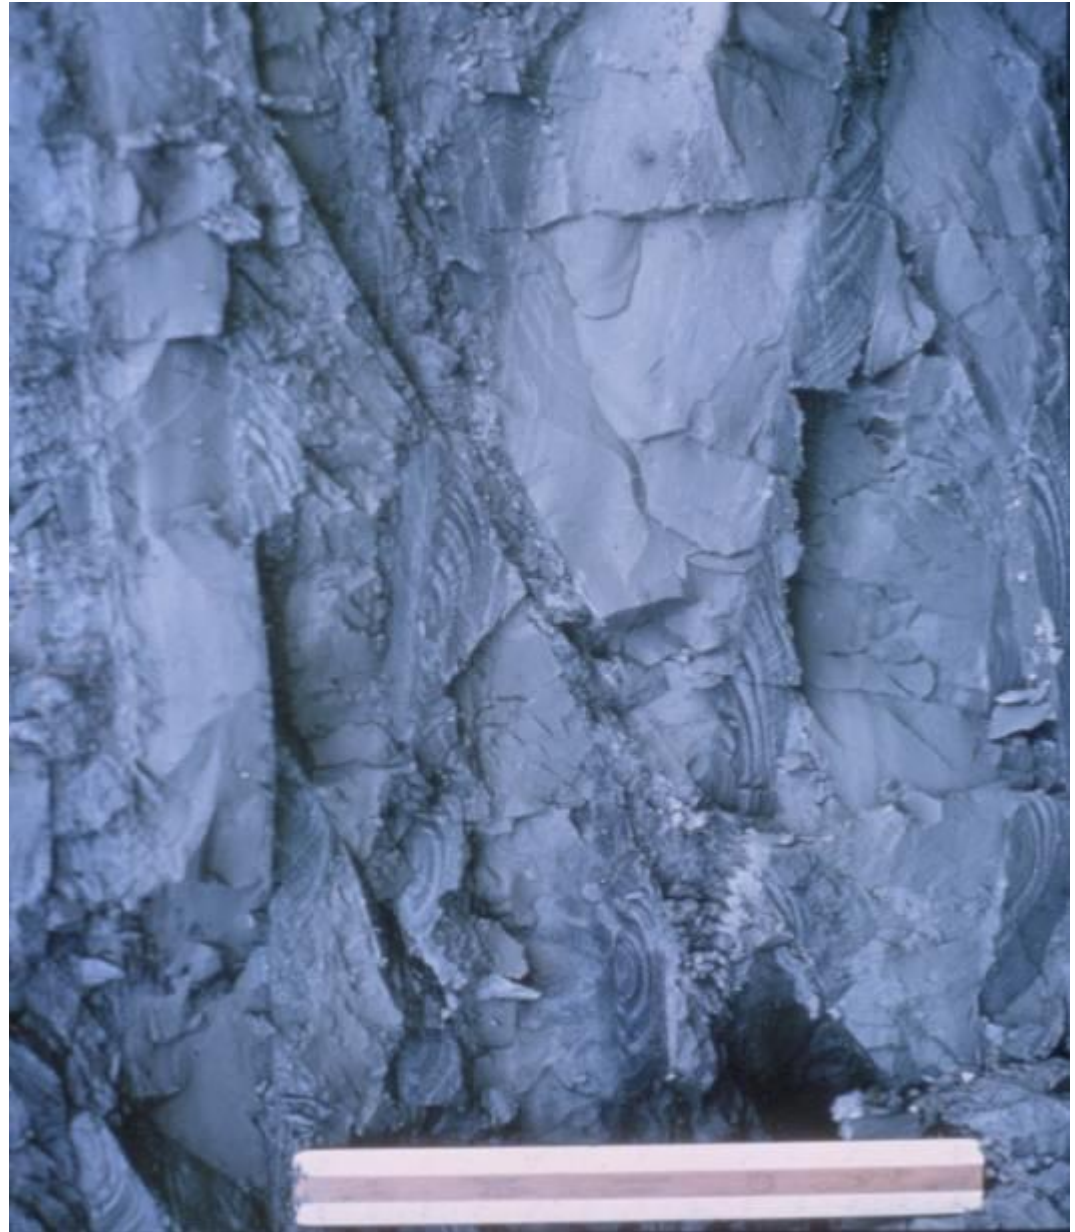
Fractured Glacio- lacustrine Clay

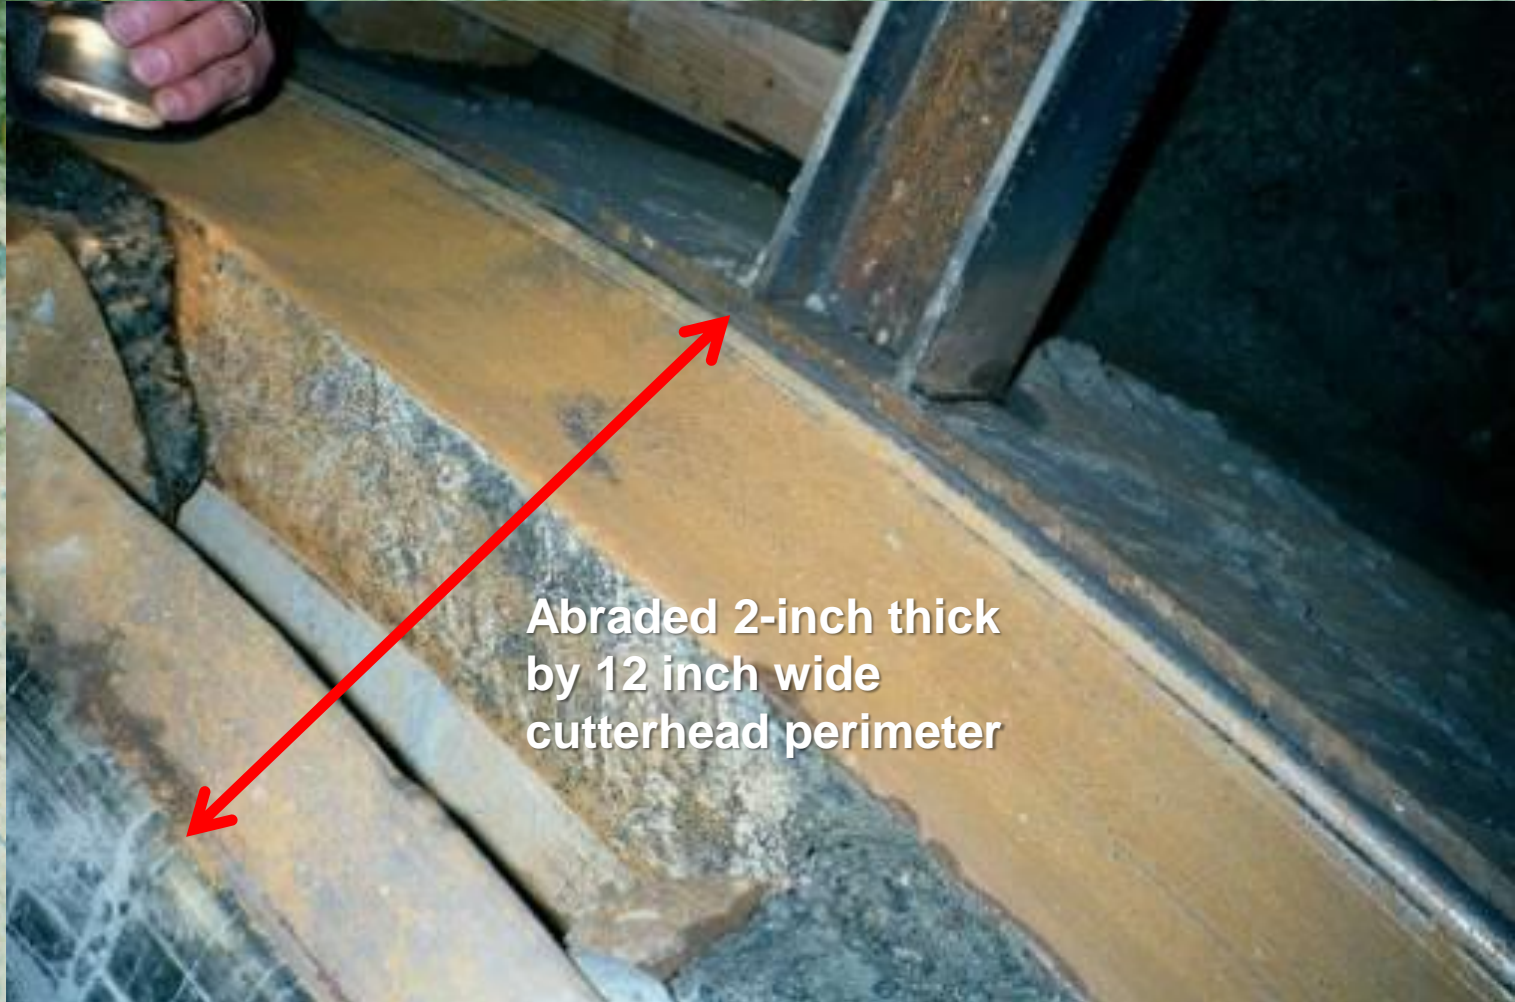
Denny/Mercer St. CSO Tunnel - 2002

Abraded 2-inch thick
by 12 inch wide
cutterhead perimeter

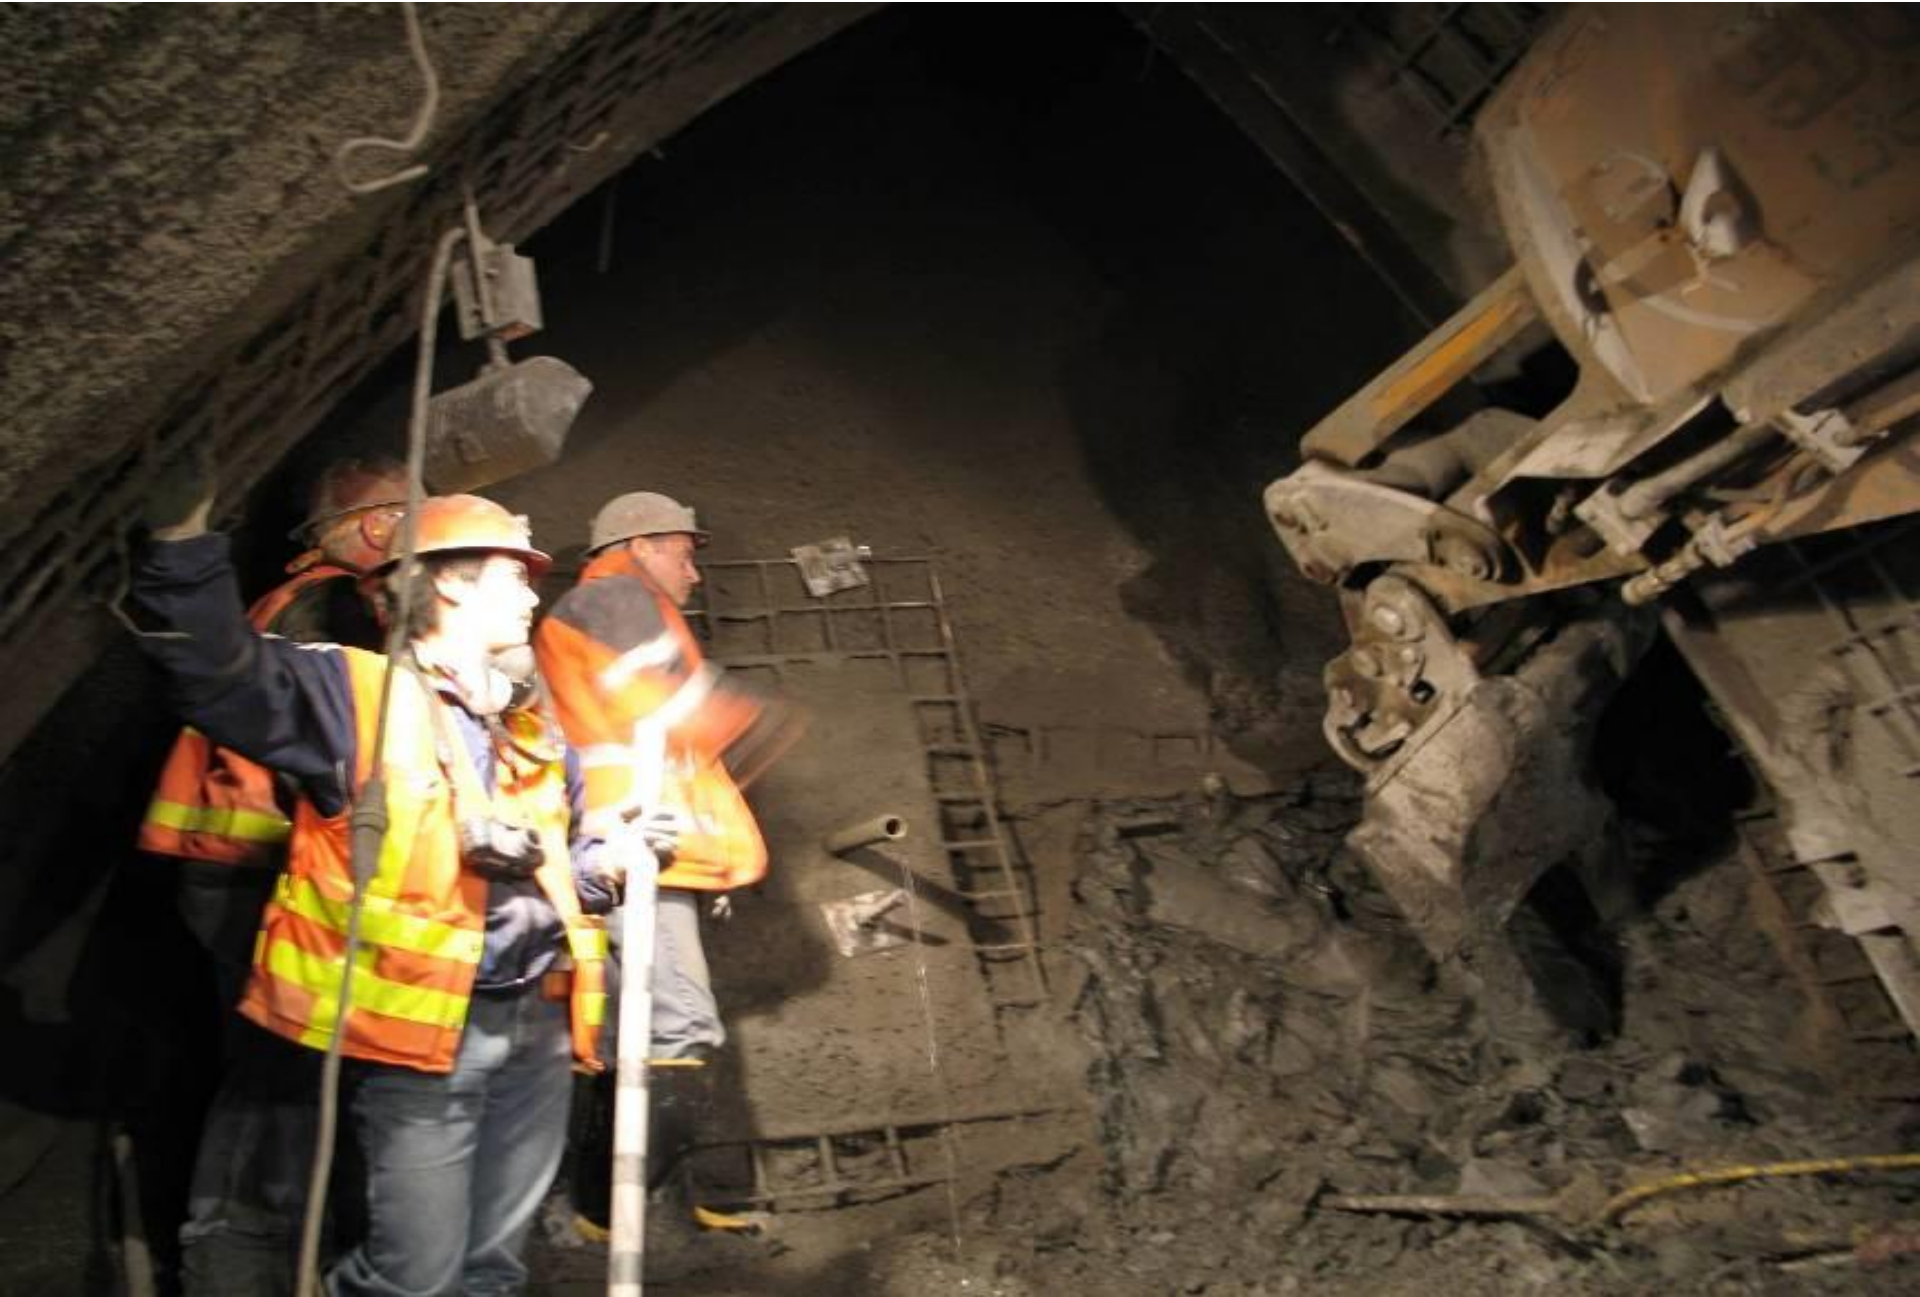
Face Support in Slickensided Clay

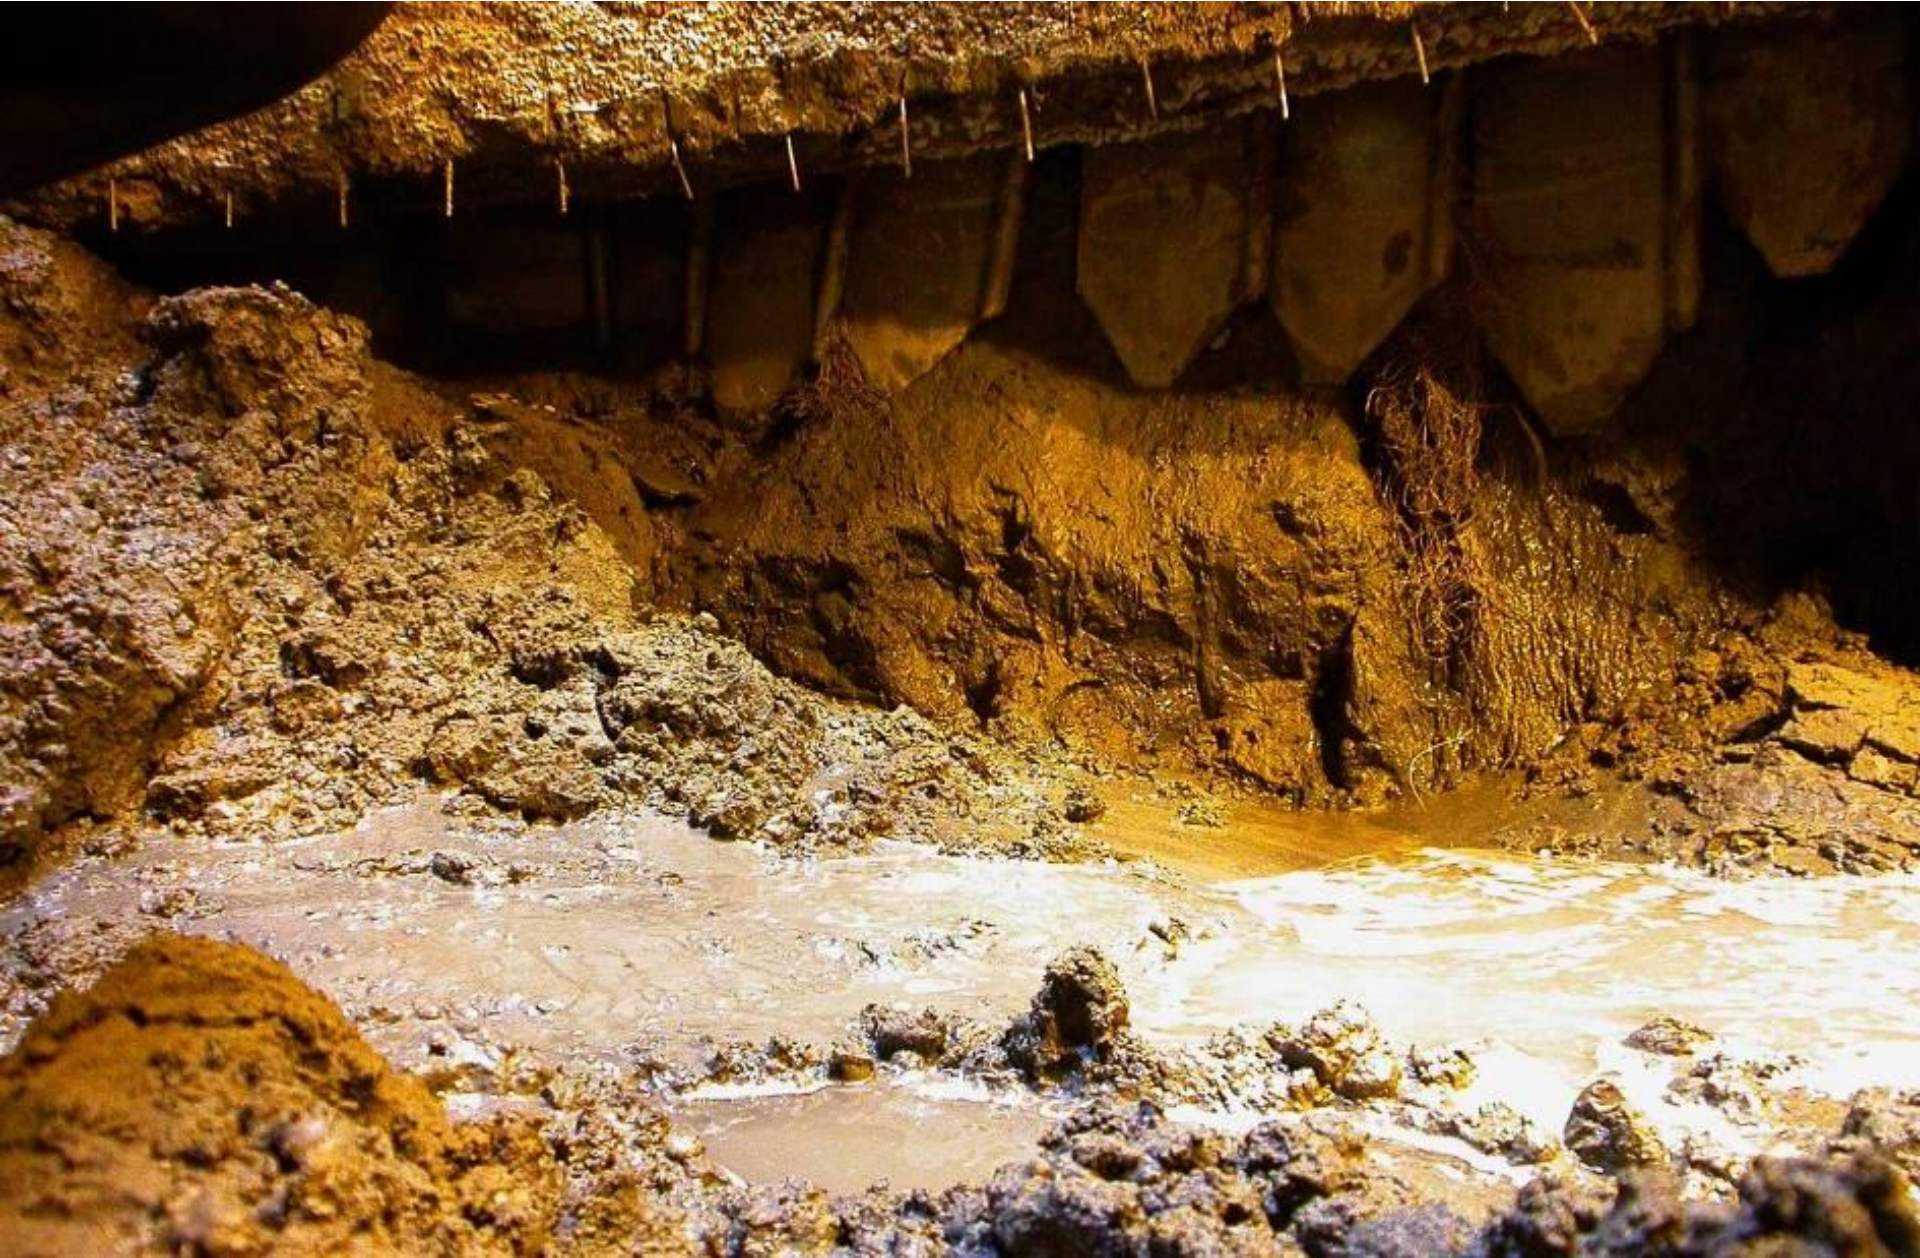
Flowing Sand
