# Concrete Pavement Joint Sealing

19<sup>th</sup> Arizona Pavements/  
Materials Conference

November 16, 2022

Kurt Smith  
Applied Pavement Technology, Inc.

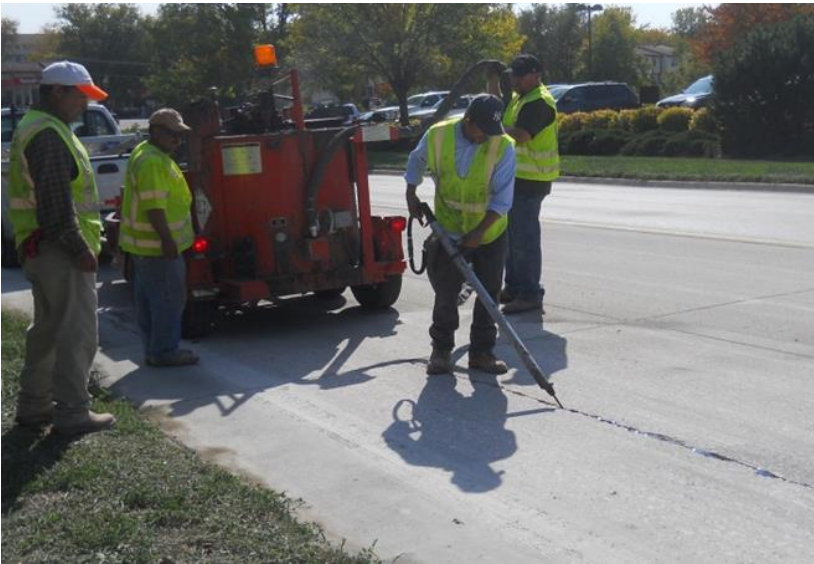
- Placement of an approved sealant material in an existing joint (transverse or longitudinal)

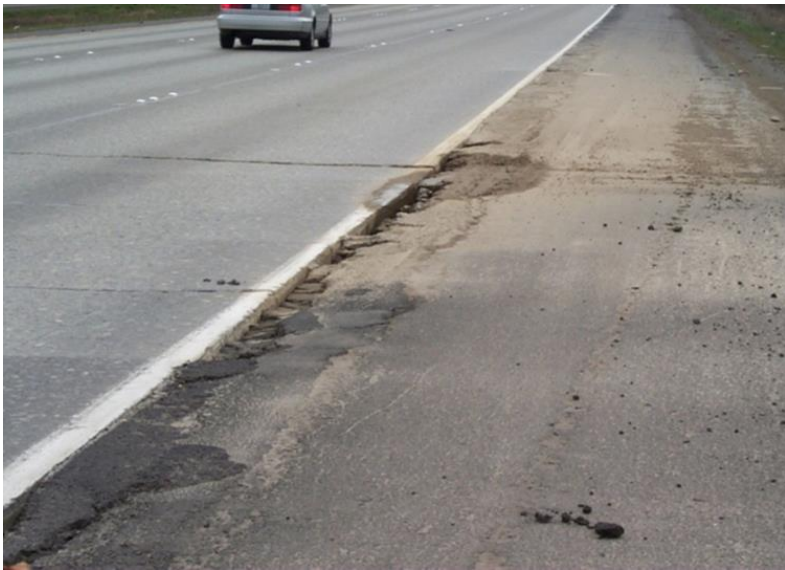
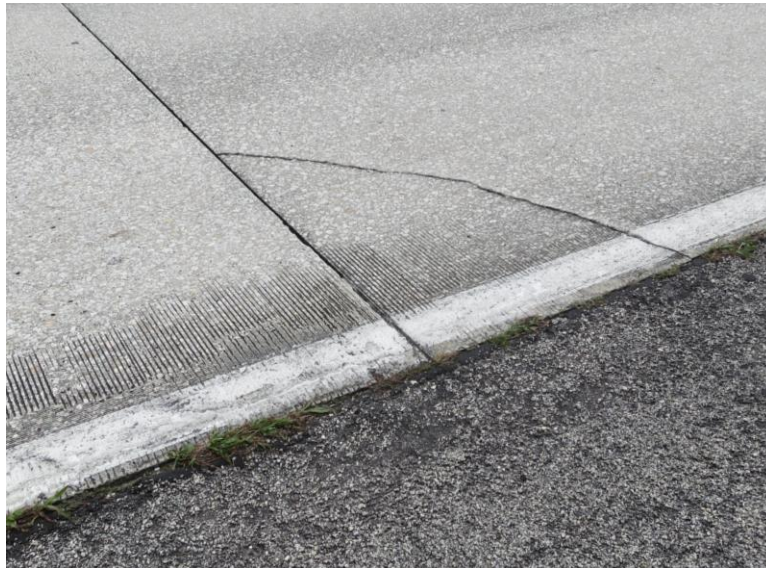
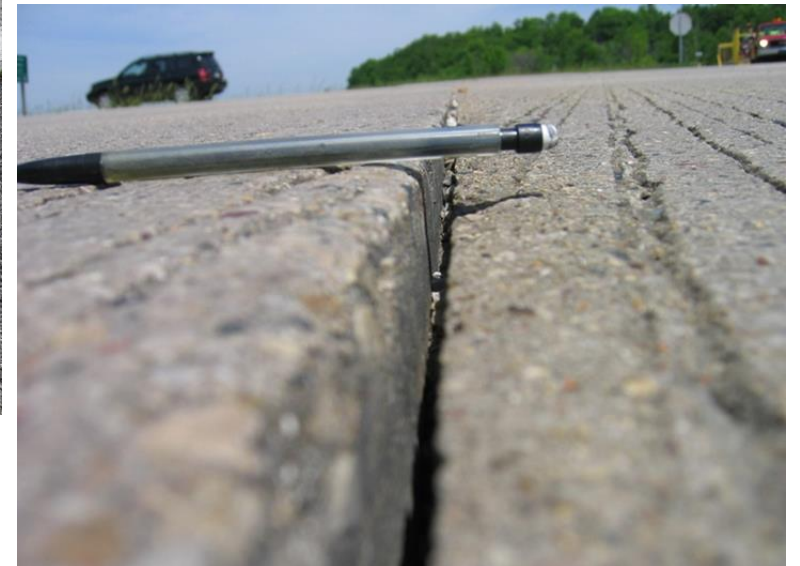
# Why Do We Seal Joints?

- Minimize moisture infiltration

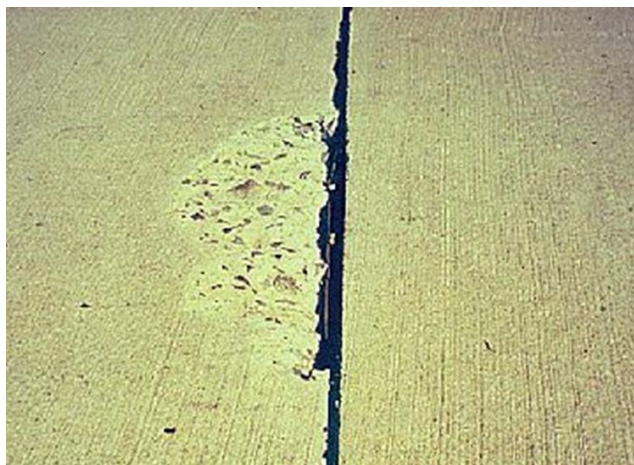
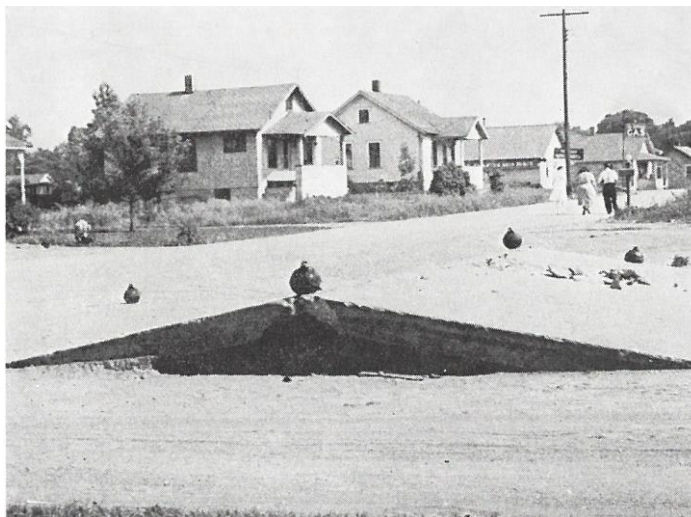
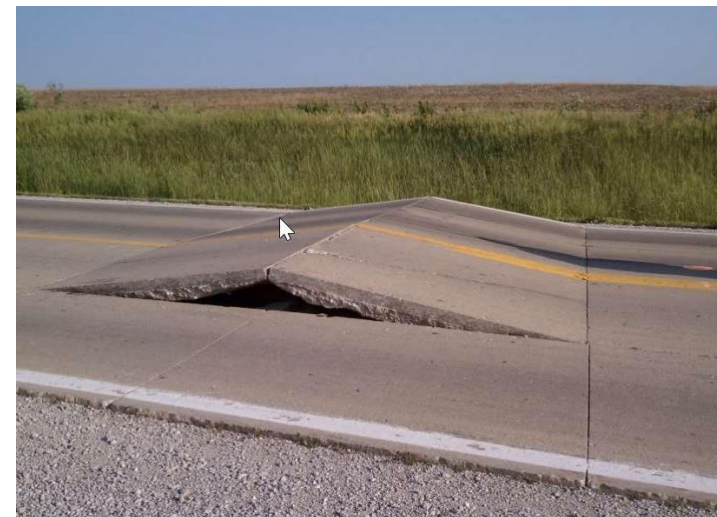
# Why Do We Seal Joints?

- Reduce incompressibles

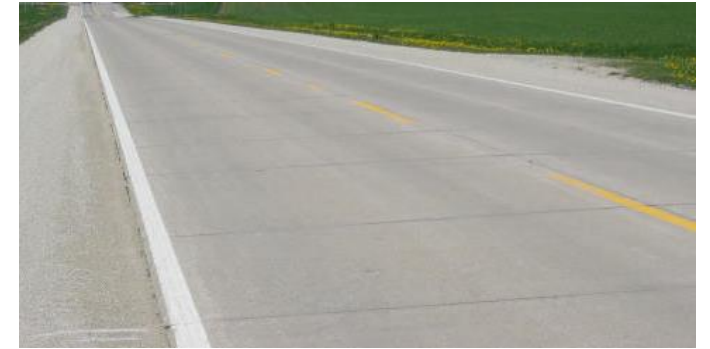
Silicone (AZ)

# What Do We Expect?

- 2019 FHWA Tech Brief
  - » Hot-Poured Sealants: 3 to 8 years
  - » Silicone Sealants: 8 to 10+ years
- Longer performance also documented
- Factors affecting performance:
  - » Movement (slab size, base, climate, loading)
  - » Joint installation/preparation
  - » Sealant properties and design

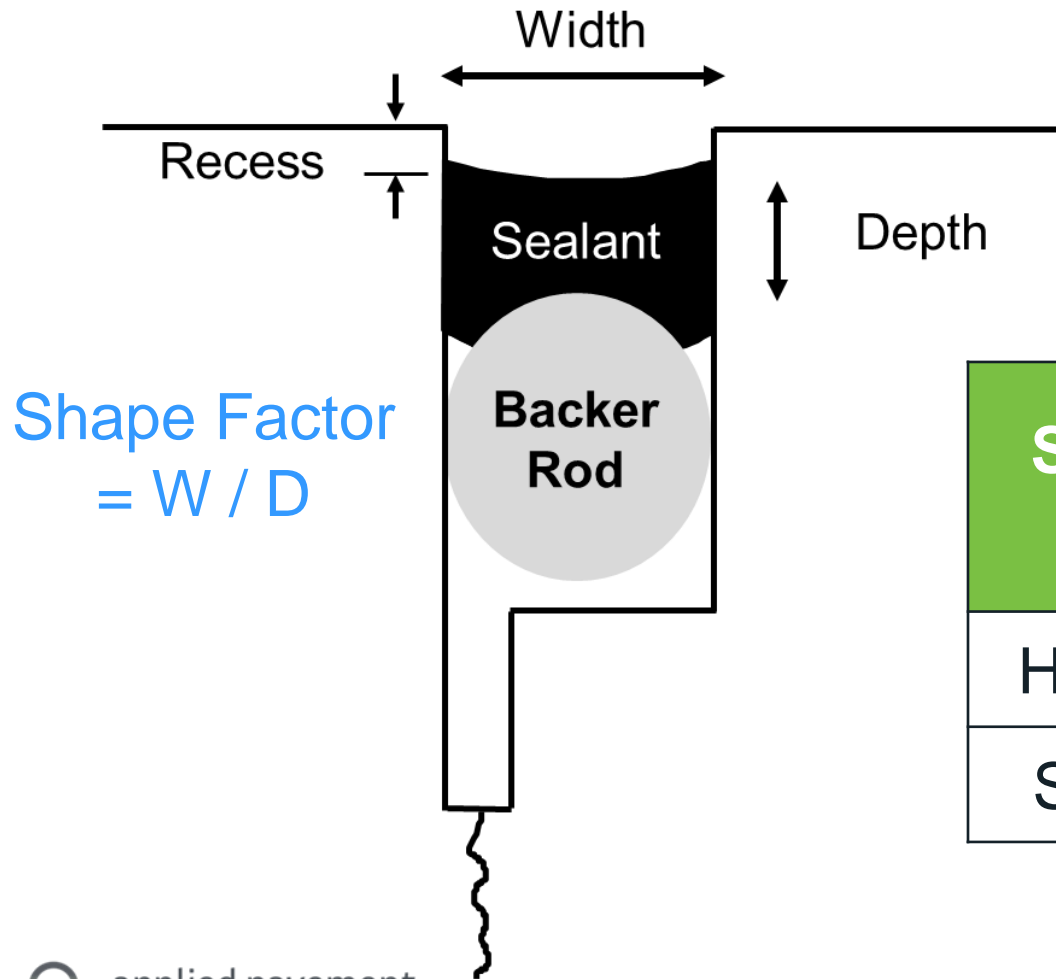
# What Have We Learned: Joint Shape Factor

Sealant Type	Recommended Shape Factor (W:D)	Recommended Recess
Hot Pour	1:1	Flush Fill
Silicone	1:1 to 2:1	1/4 to 3/8 inch

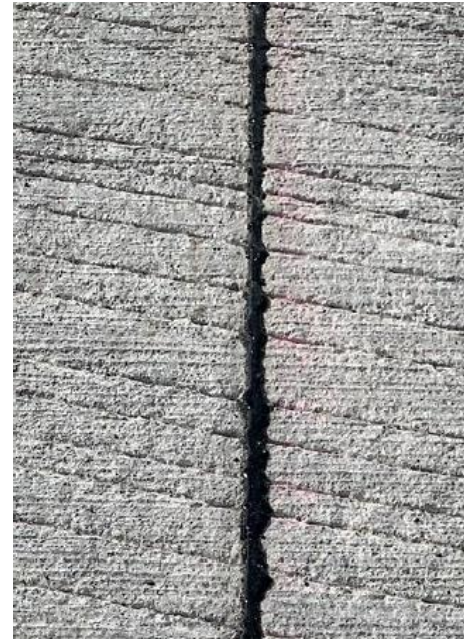
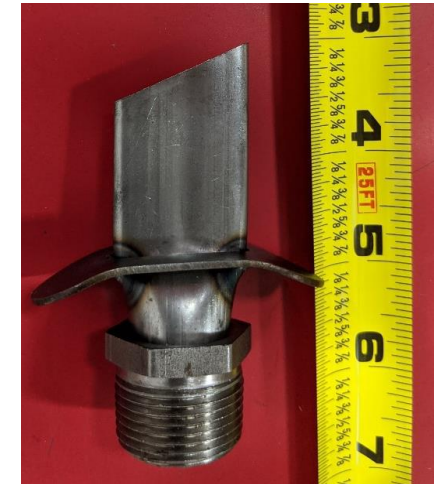
## Narrow is Better

- Advantages:
  - » Allows for future resealing
  - » Reduces noise/wheel slap
  - » Uses less material
- Narrow joint accommodations
  - » 3/16 to 1/4 inch joint for cleaning and to better accept sealant
  - » Special fixtures for media blasting and filling joints
  - » Consider anticipated movements for required widths

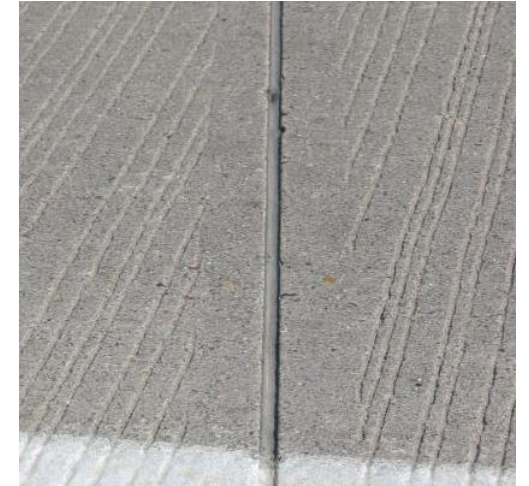
- Use quality materials meeting project needs
- Silicone (ASTM D5893)
  - » Non sag or self leveling
  - » Long-term performance in several ADOT studies (e.g., I-17, US 60, I-10)
- Hot-Poured (ASTM D6690, types I-IV)
  - » Standard or Low Modulus
  - » ADOT specifies Type II/III
  - » Moderate/mid-term performance

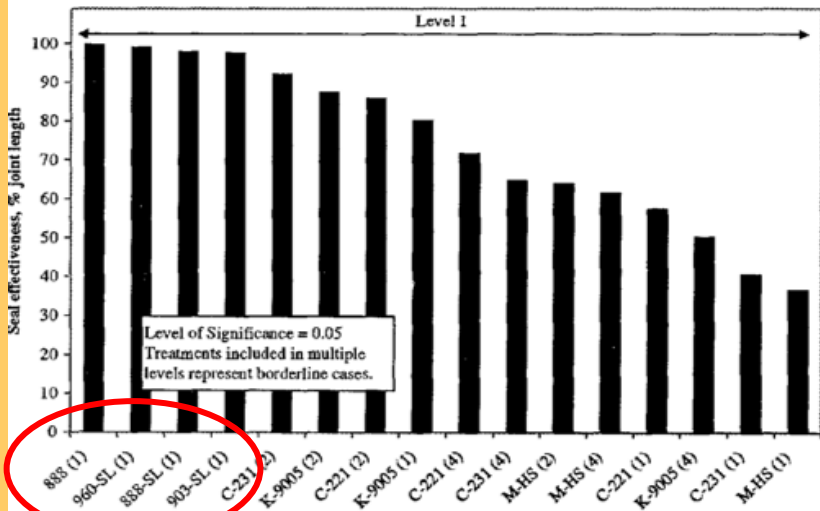
I-17, Phoenix  
-1991 reseal  
~82 months

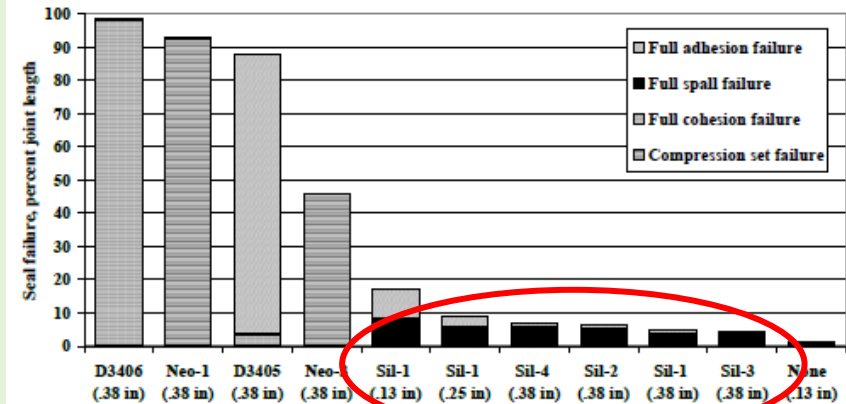
~180 months  
(15 years)

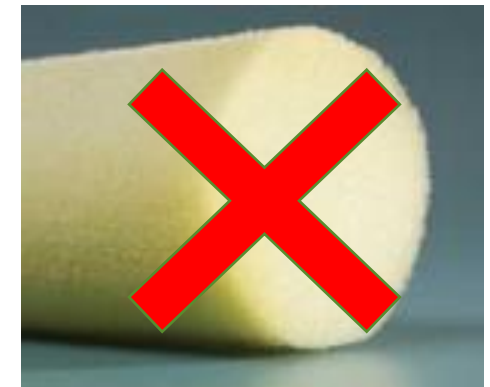
Open Cell  
(not recommended) 20

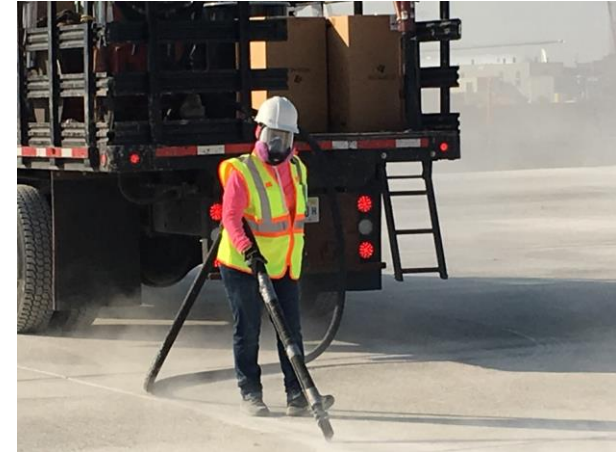
Media blasting

- Joint preparation/cleaning
  - » Media blast to remove slurry from sidewalls (both sides of joint)
  - » Airblasting to remove any final debris
- Backer rod installation
  - » Fit snugly in joint

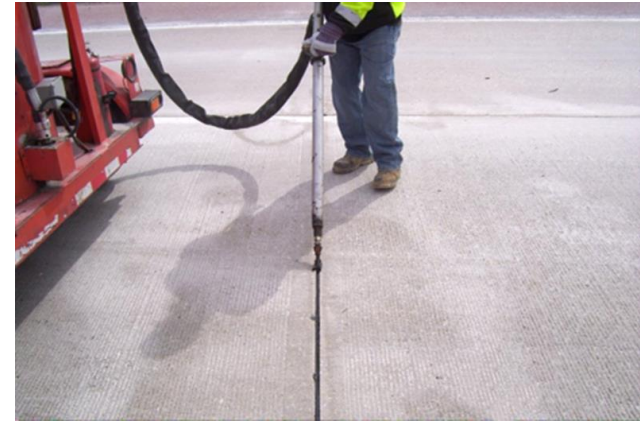
Hot-Poured

- New concrete cured 7 days
- Joints “clean and dry”
- Weather conditions
  - » Ambient temperature (typ. 40 °F & rising)
  - » No precipitation
- Monitor HP sealant temperatures
- Fill from bottom up (limit air pockets)
- Proper tooling for silicone (non-sag)
- Proper recess
  - » Hot-poured: flush fill
  - » Silicone: 1/4 to 3/8 inch

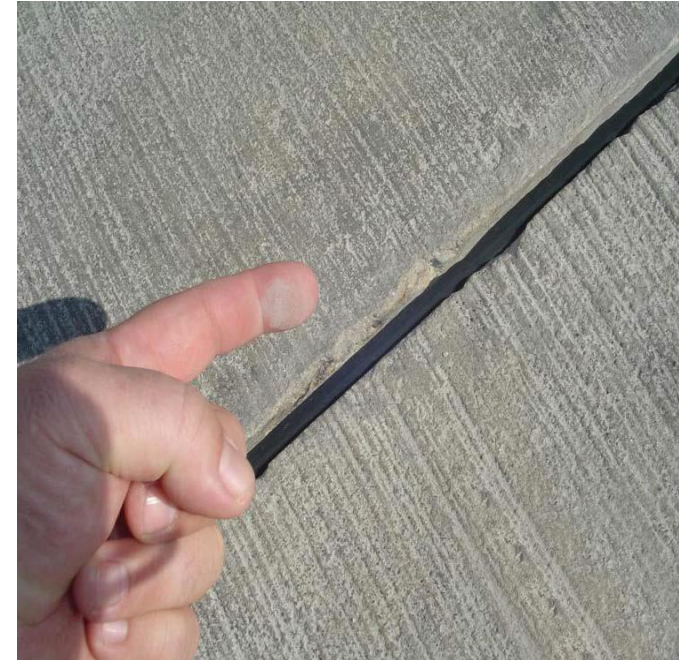
- Effective sealant bonding to joint sidewalls is critical
- What inhibits bond?
  - » Concrete not cured out
  - » Joint faces not properly cleaned (sawing residue, dirt, dust, debris, old sealant, etc.)
  - » Moisture in joint
  - » Damage to concrete substrate
  - » Sealant/concrete incompatibility
  - » Oil/moisture in compressed air

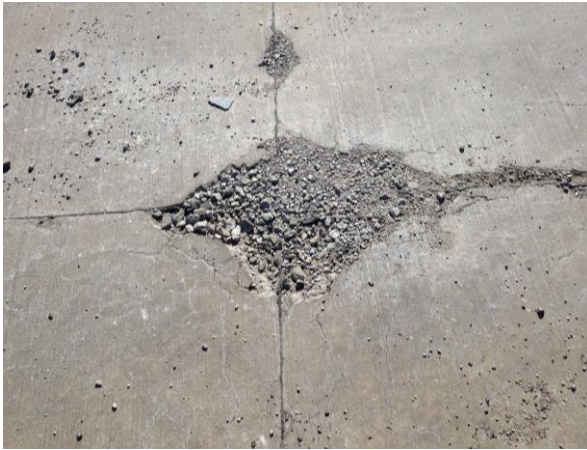
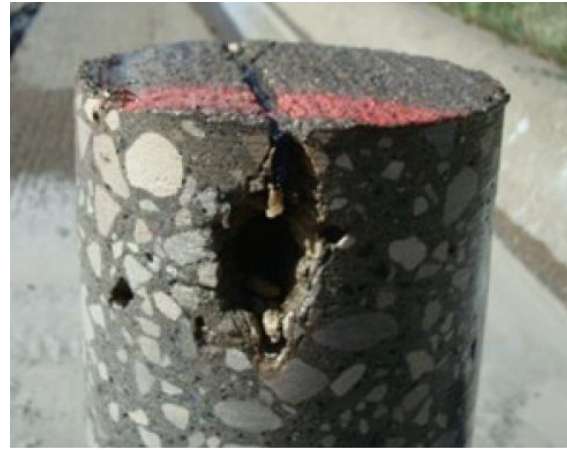
- Detrimental impacts of certain deicing chemicals
