Innovations in Full Depth Reconstruction of Interstate Roadways in Arizona

Tad Niemyjski, P.E.
ADOT Geotechnical Services Section

Arizona Pavement/Materials Conference
November 16, 2023

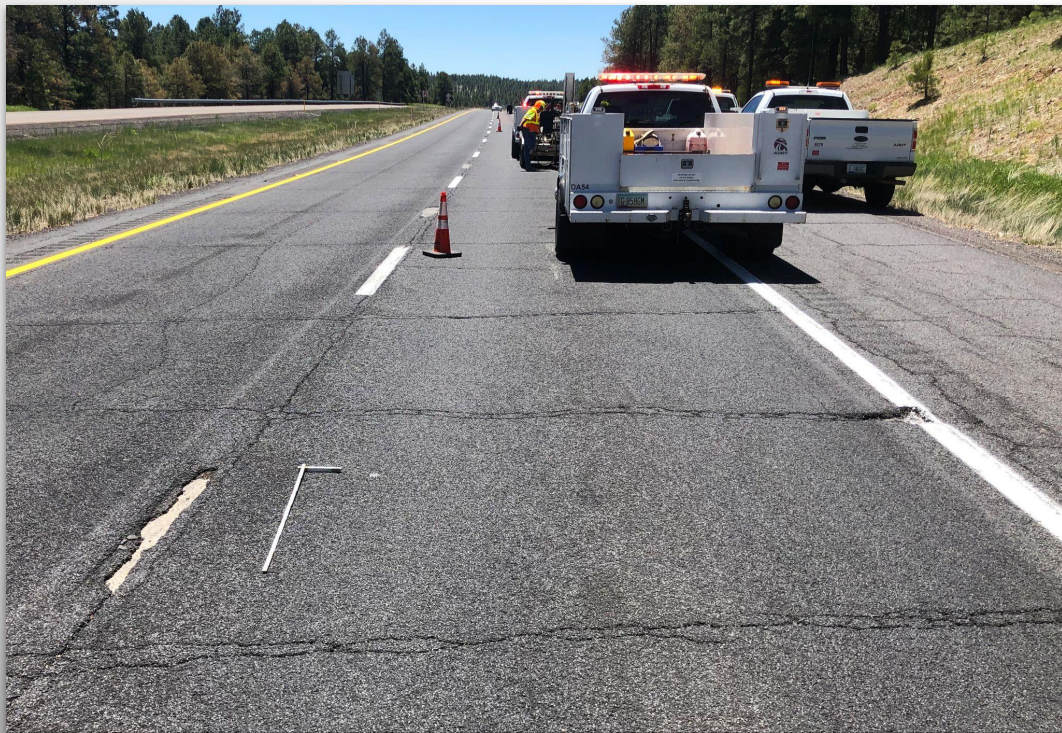
- Rehabilitation of 29 miles south from Flagstaff to the Coconino County Line
- Existing roadway is primarily PCCP pavement with friction course overlay
- New pavement would be PCCP with 1.5 inch leveling course of AC

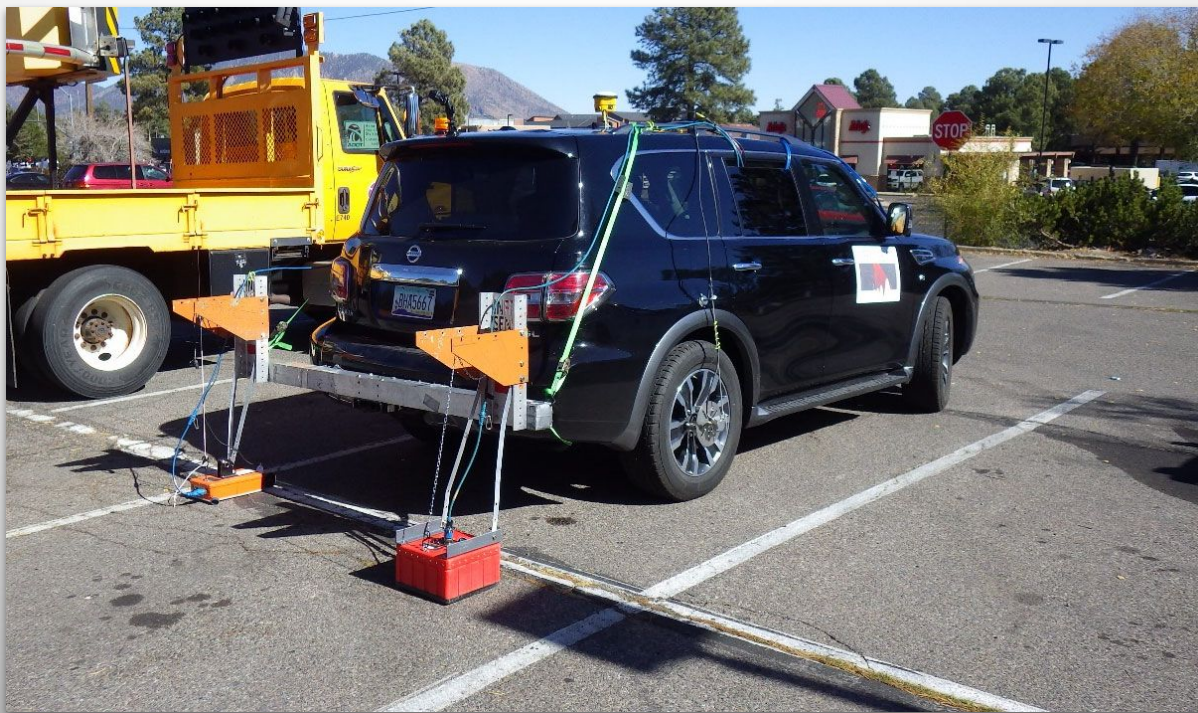
Mobile GPR Survey

- Scoping Challenge: amount of PCCP that would have to be replaced during construction
- Standard pavement coring and crack mapping was conducted
- GPR Survey of about 54 lane-miles of highway was completed in April of 2020
